## Earthen Manure Storage Seepage

### A Study of Five Typical Sites

Here is a summary of the interim report on "A Survey of the Environmental Security of Earthen Manure Storage Ponds in Alberta."

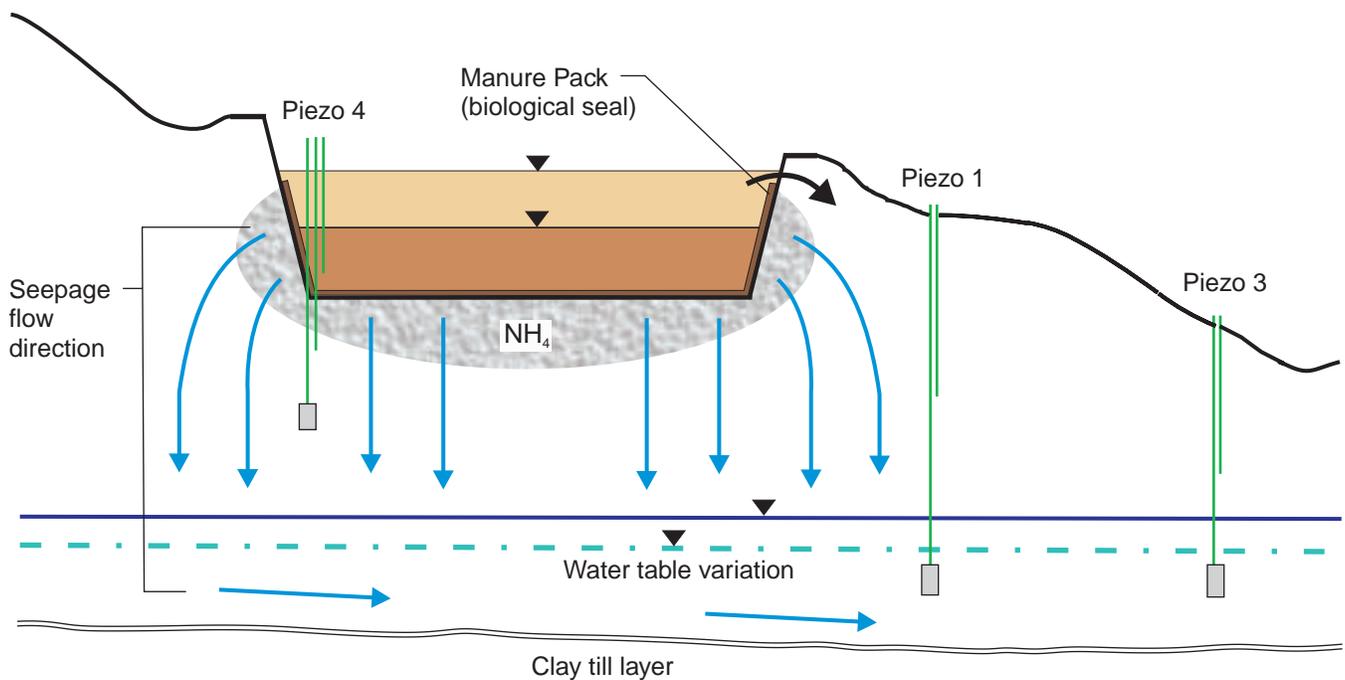
Figure 4. Schematic of seepage from a highly permeable site

An investigation of the data sources suggests that this earthen manure storage was built into a sand dune. The producer indicated there was some obvious seepage when the storage was first constructed. The natural biological sealing action of the manure is assumed to have caused the end to this seepage.

Ammonia was found in soil samples below the earthen manure storage, probably caused by periodic breakdown of the manure seal and intermittent seepage. Given that the surrounding soils are unsaturated, seepage is mostly vertical, which is probably why higher concentrations are found in the extreme downslope piezometer, along the clay till barrier and in a perched water table.

- Some seepage and contaminant movement is occurring at this site and is having a negative impact on the local shallow groundwater within the upper sandy soil layer. However, a continuous, severe contaminant plume from the manure is not evident.

- Most, if not all of the seepage from the manure at this site is through unsaturated flow and diffusion mechanisms.
- Preferential flow during periods when the manure seal has broken down is likely responsible for most of the contaminant movement at this site. The manure sealing is probably responsible for preventing the development of a major continuous plume from this site.

- Under today's standards, a review of the remote site characterization data would have resulted in a recommendation to do a site-specific investigation. A qualified professional would have recommended a constructed clay liner, or a steel or concrete storage.

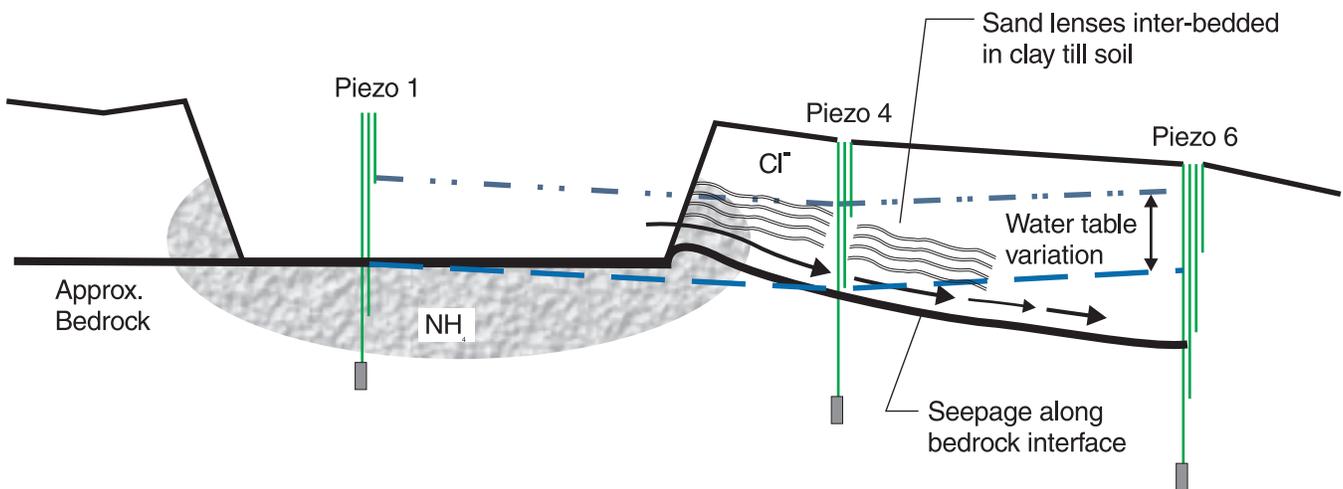
Figure 5. Seepage along bedrock interface where all soil was scraped from the EMS bottom.

There is indication of a zone of seepage movement adjacent to the downslope corner of the manure storage that coincides with local sand layers. Evidence suggests that the top soil layer and tree roots in the berm may be contributing to this seepage. The bedrock-berm interface may act as a conduit for seepage. Water and soil sampling suggests that seepage is limited to the perched water table, and is not entering the bedrock layer.

- Evidence that seepage is occurring through sand streaks and along the bedrock interface supports the idea that a soil buffer should be present between the bottom of the earthen manure storage and the bedrock layer.

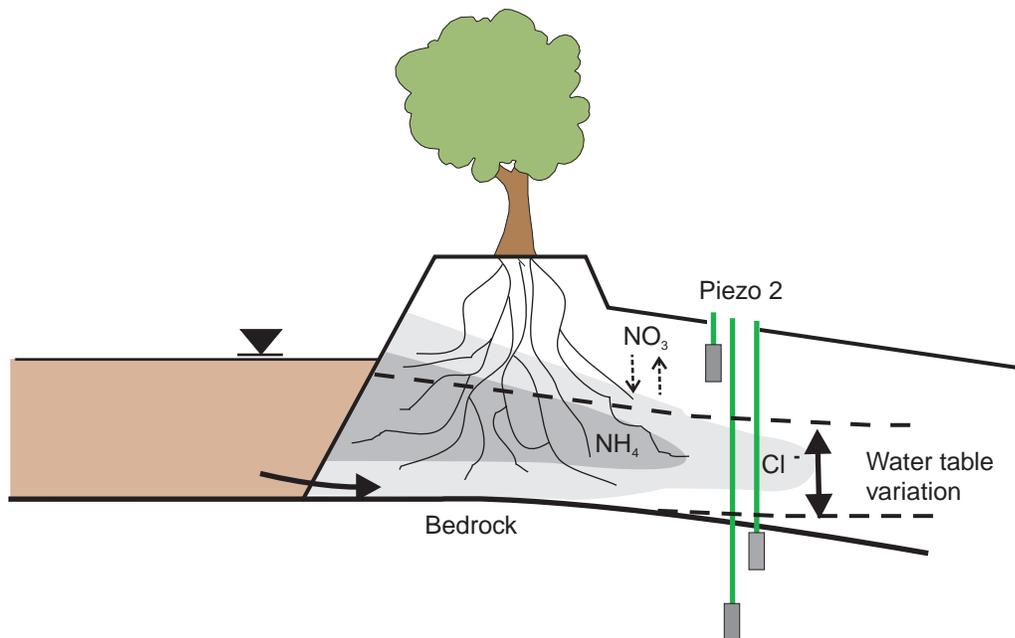
Figure 6. Tree roots in the berm promote preferential flow.

- Evidence that seepage is occurring through the side of the storage (where a tree is growing into the berm) suggests tree root paths may be causing the high seepage rates at this location.

- Evidence of seepage due to tree roots in the berm shows that maintenance is important to continued performance. Operators of earthen manure storages should inspect and maintain the structures regularly.
