# Nutrient Beneficial Management Practices Evaluation Project

**Whelp Creek Sub-watershed Tour  
August 10, 2010**

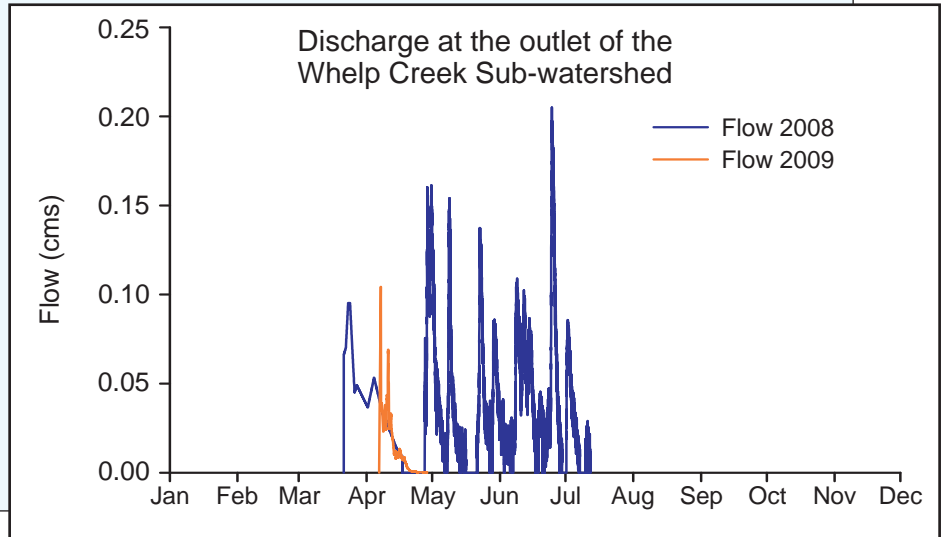
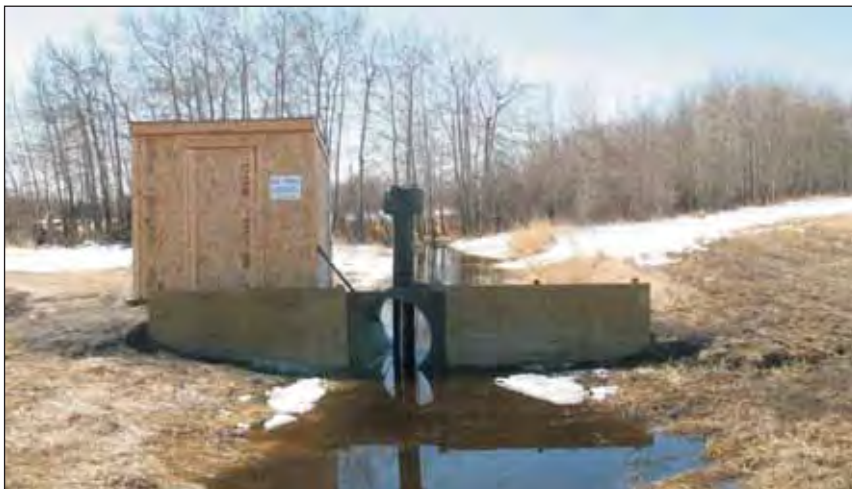
Snowmelt is usually the predominant form of runoff in Whelp Creek.

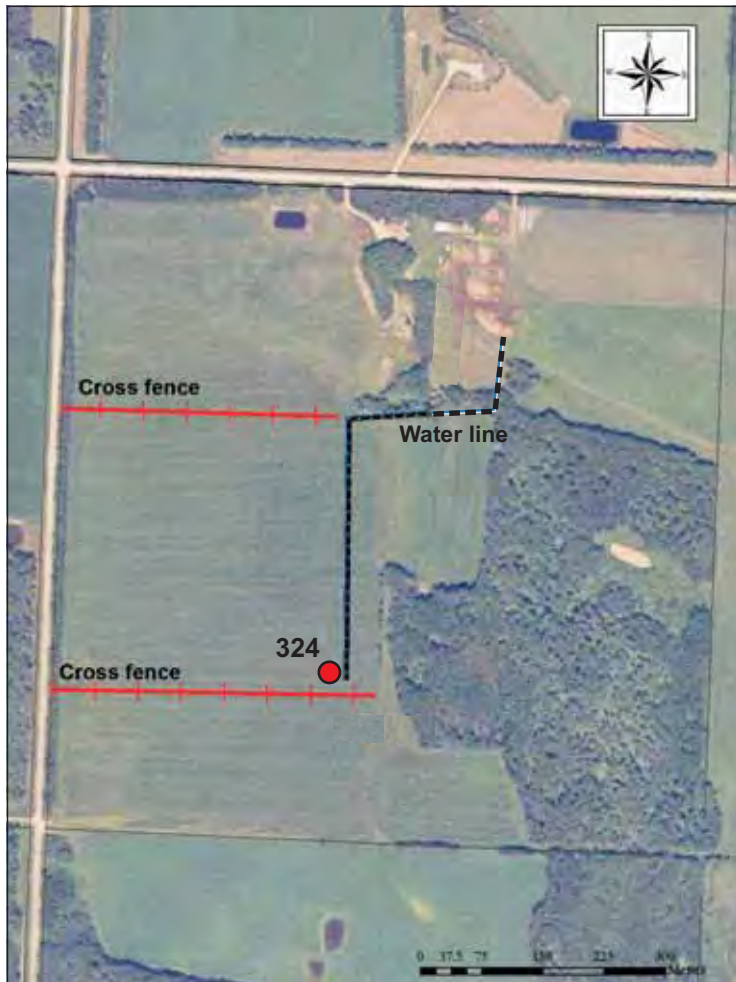
The South Pasture site showing the new cross fencing and the new water line.

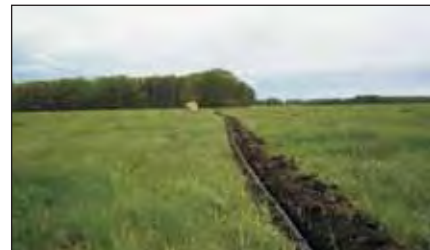
Water line installation

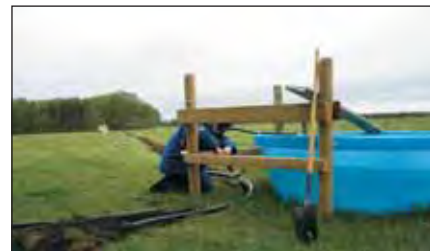
Water connection for trough

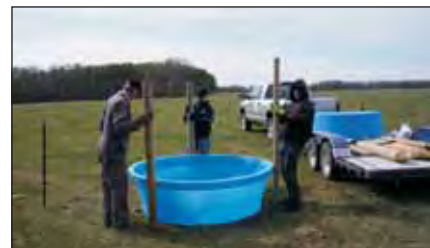
Trough for off stream water

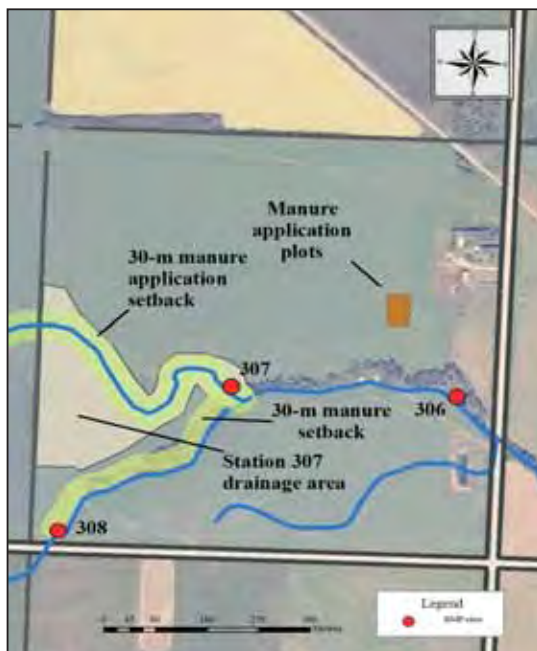
The East Field Site showing 3 water quality monitoring stations and the 16 ha drainage area to 307. Liquid dairy manure will be applied to the 16 ha and water quality will be monitored in 2010. The 2009 manure application plots are shown.

- ▶ Surface manure was applied in the drainage area of 307
- ▶ A 30 m setback from the drainage channel was used
- ▶ Manure was applied with AerWay® based on a 1-yr phosphorus removal

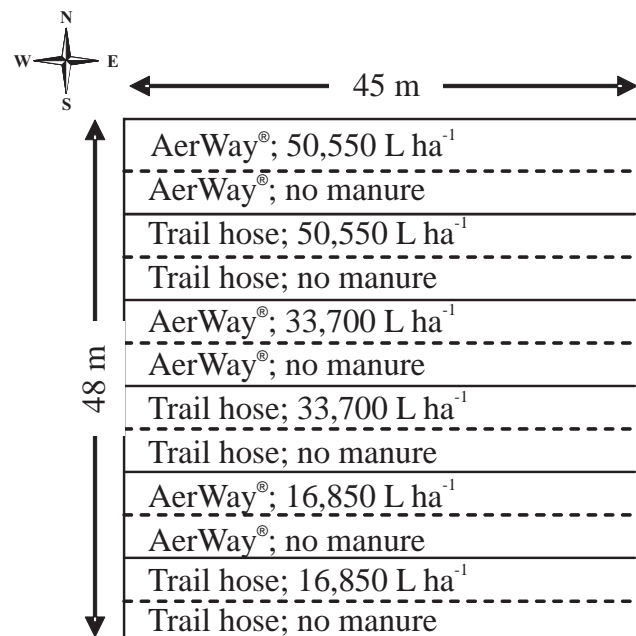
The manure plot trial showed a yield increase of about 10% when manure was applied at the highest concentration. Yield differences were less for the lower manure application rates and there was no clear difference between the two application implements.

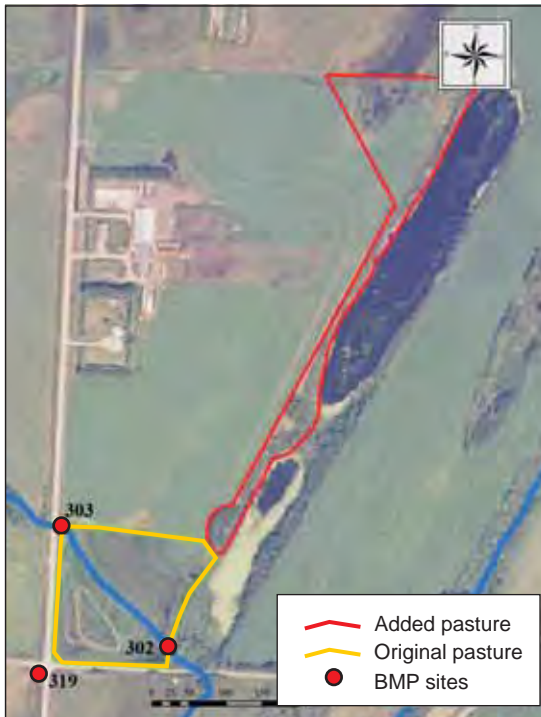
The North Pasture site showing Whelp Creek and the water monitoring stations.

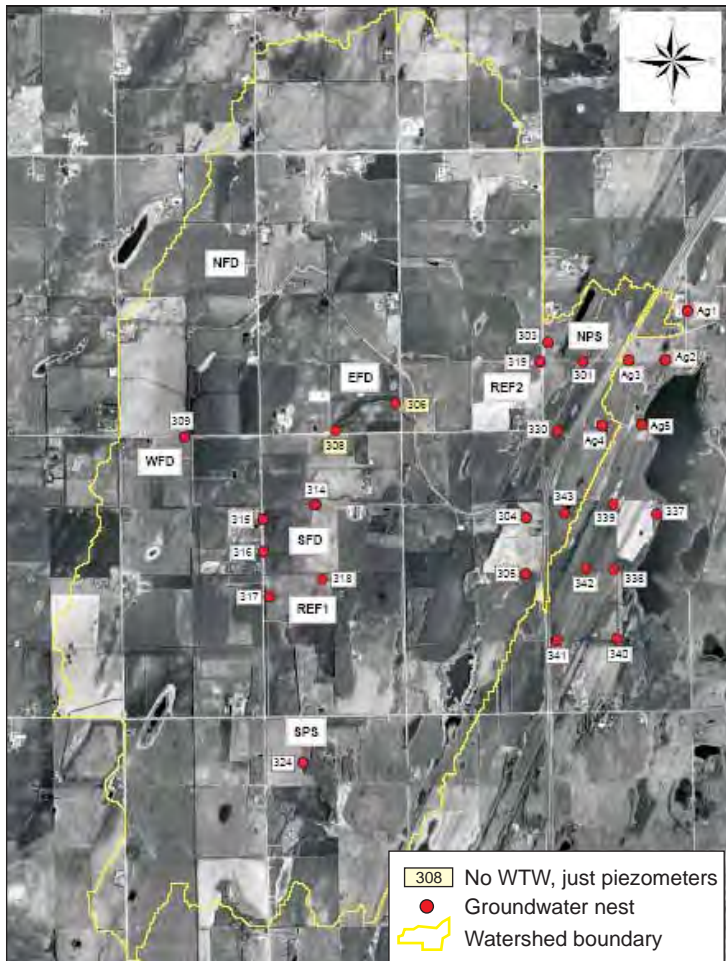
Map of the groundwater nests in the Whelp Creek area

- ▶ 17 nests in the Sub-watershed plus 10 nests east of the Sub-watershed
- ▶ nest = 1 water table well + 2 piezometers

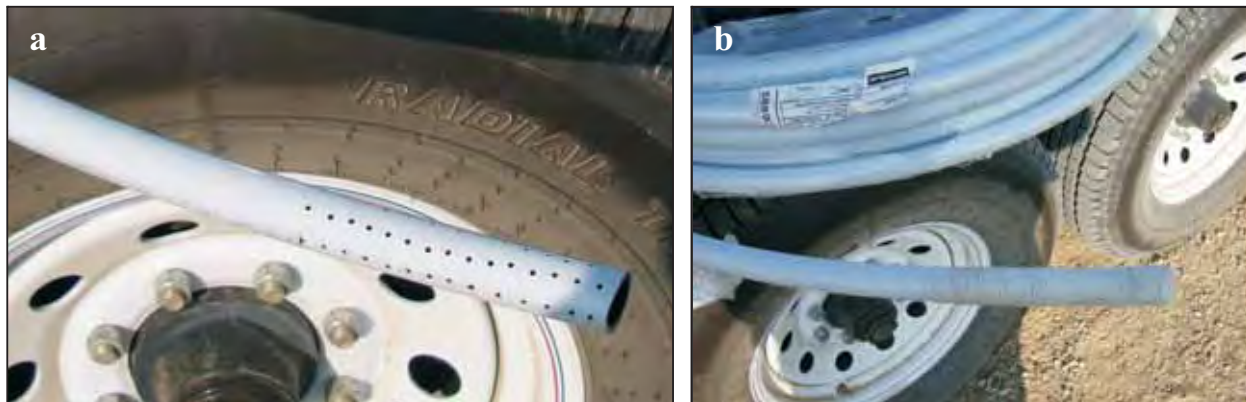
Stages of piezometer screen construction: (a) slotted interval (b) completed piezometer screen.

- ▶ Water table well depths range from 2.4 m to 7.3 m (average 4.1 m); 3 m slotted interval
- ▶ Piezometers were installed at two depths ranging from 2.8 m to 17.1 m (average 7.7 m); 0.11 m slotted interval

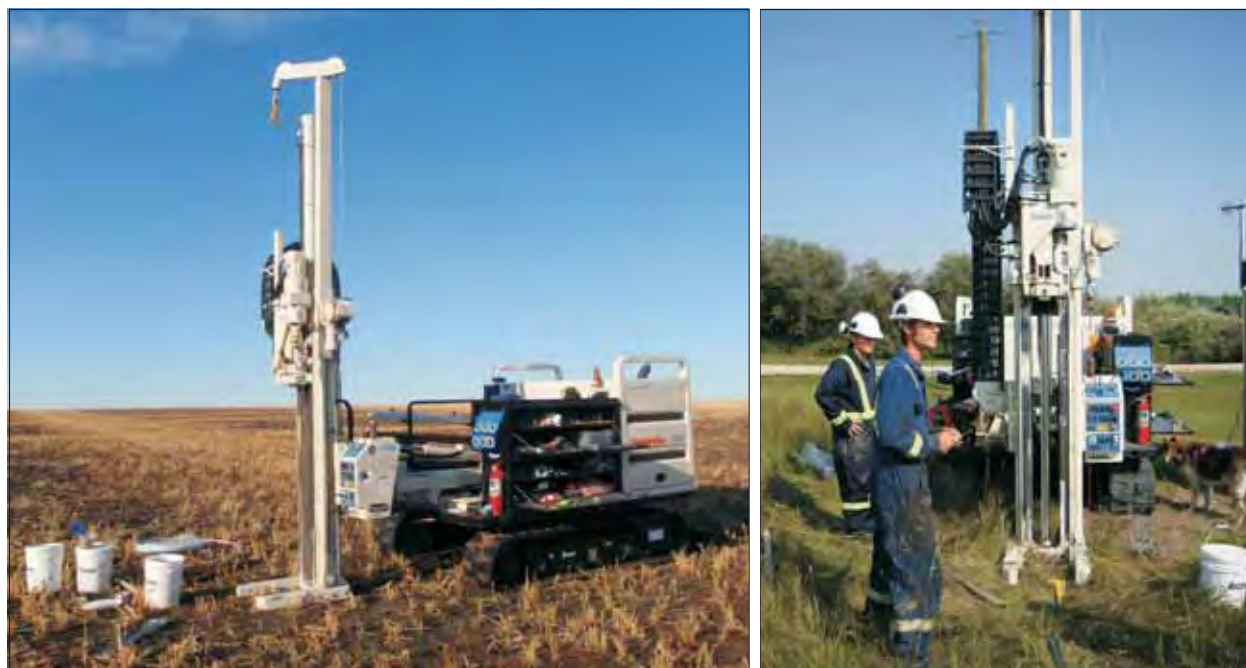
Groundwater wells were installed using a Geoprobe® 7730DT (a hydraulically powered soil probing unit), which allows installation with minimum soil disturbance.

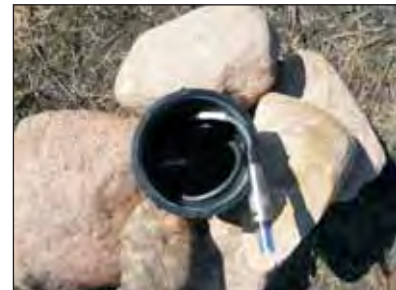
Levellogger in the groundwater well near the watershed outlet records water table height.

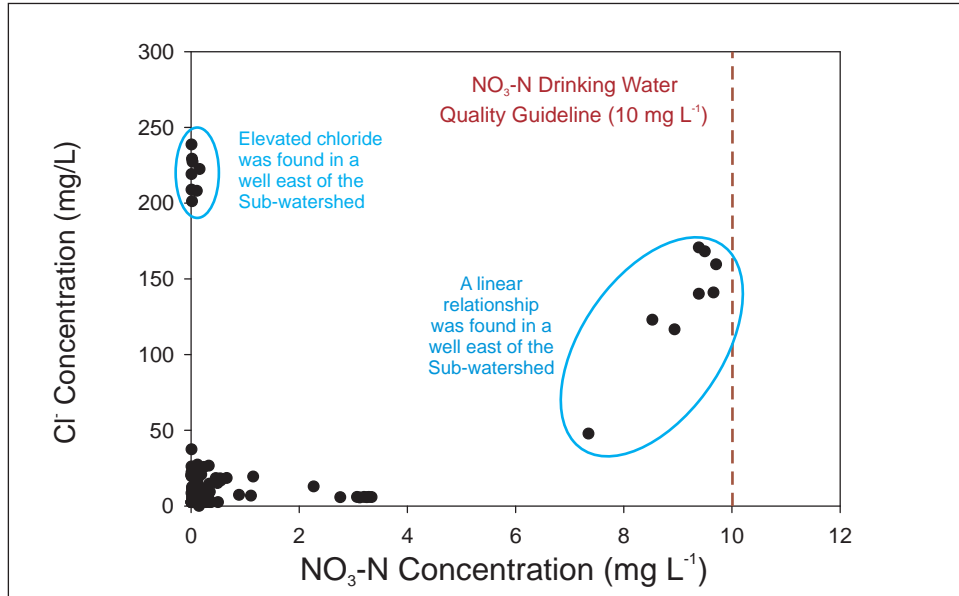
Nitrate-nitrogen ( $\text{NO}_3\text{-N}$ ) and chloride ( $\text{Cl}^-$ ) concentrations in groundwater from the Whelp Creek area in spring 2010.

- ▶ Nitrate-nitrogen and chloride concentrations in the Whelp Creek Sub-watershed are generally low, and similar or less than surface water concentrations.
- ▶ The nitrate-nitrogen concentrations do not exceed the 10 mg/L drinking water quality guideline.

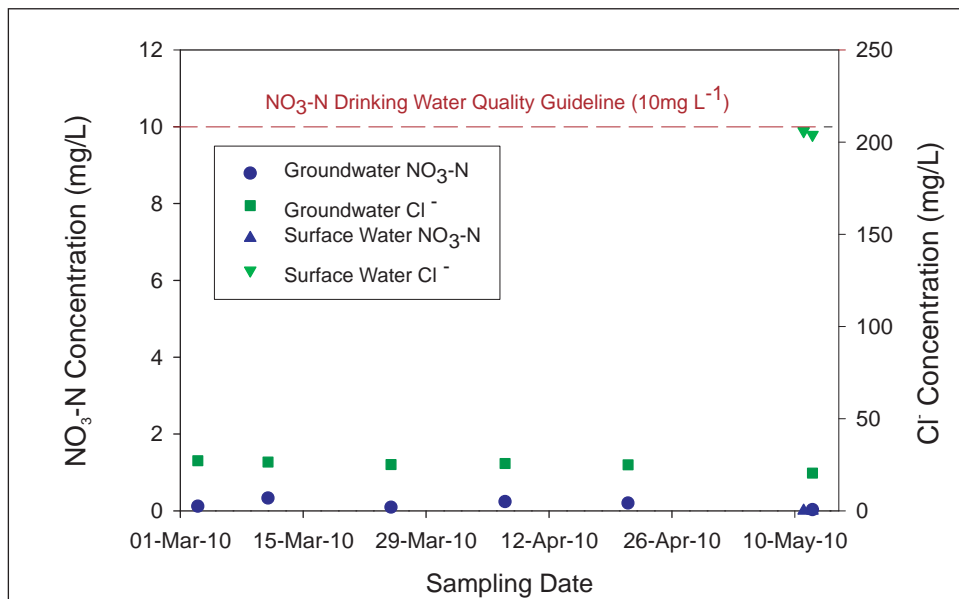
Nitrate-nitrogen and chloride concentrations in surface and groundwater near the Whelp Sub-watershed outlet in 2010.

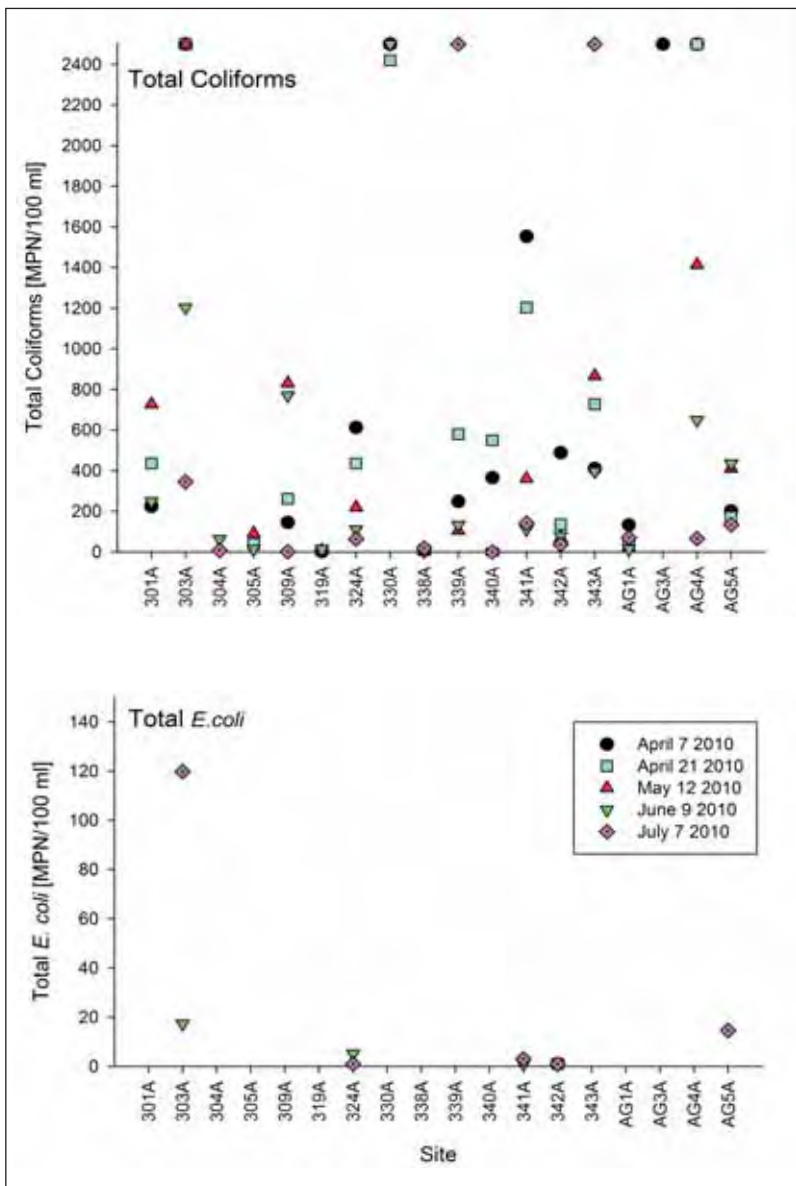
Bacteria concentrations in groundwater wells from the Whelp Creek area in 2010.

- ▶ Collaboration with Alberta Provincial Laboratory for Public Health in Edmonton, AB (Dr. Neumann).
- ▶ Water table samples collected since April 2010 at all sites that provide enough sample volume (approximately 16 sites).
- ▶ Hot spots (high concentrations) for total coliforms in the eastern part of the Sub Watershed and east of the highway.
- ▶ Generally, *E. coli* in the groundwater is absent until June and July. Presence of *E. coli* (>1 MPN/100 mL) observed at a two sites (303 and 324) and in the south, east of the highway.

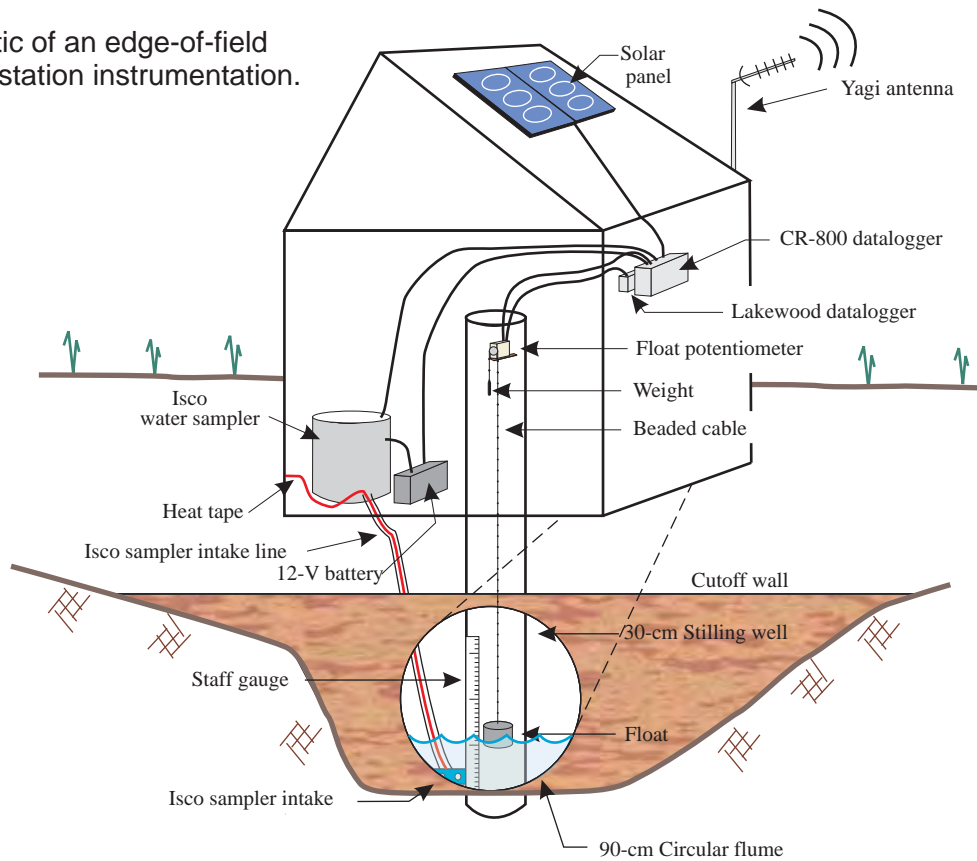
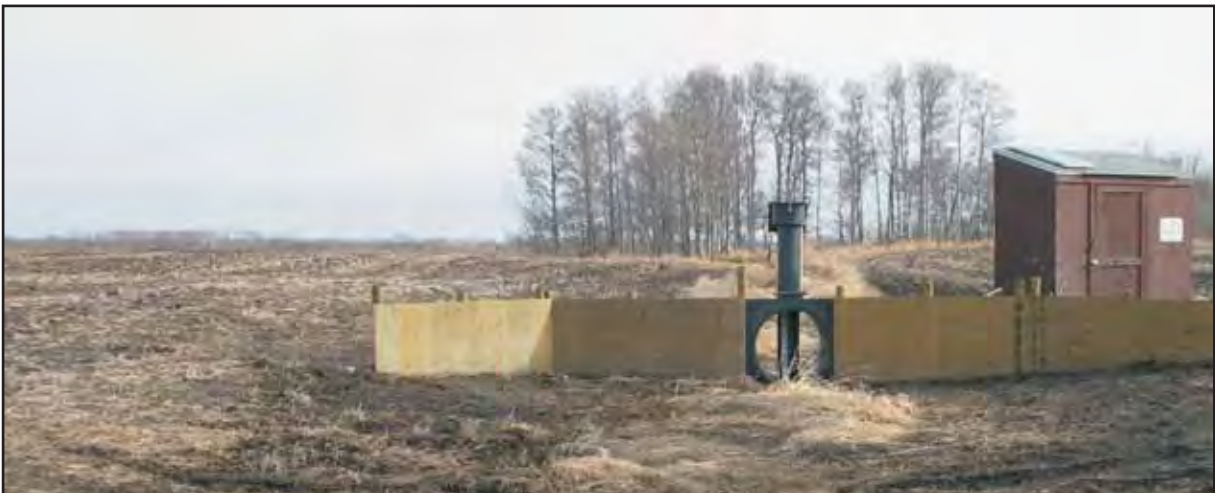
Schematic of an edge-of-field monitoring station instrumentation.

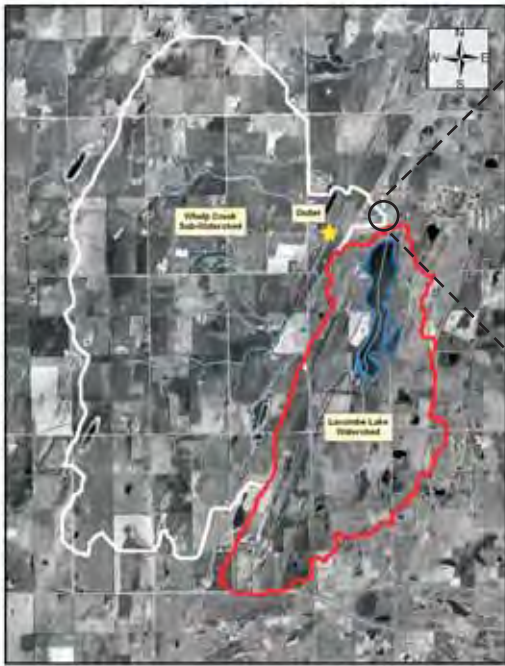
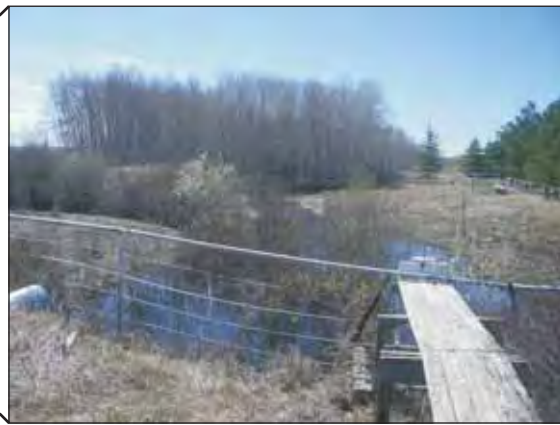
**Whelp Creek diversion infrastructure**

- ▶ Lacombe County, with the help of PFRA, constructed a water diversion project that redirected the flow of Whelp Creek into Lacombe Lake in 1970
- ▶ Intent of the project is uncertain but it was likely to stabilize lake levels and provide a domestic supply to users downstream of the lake in dry years; but, it may have also been done for flood control
- ▶ Residents around Lacombe Lake have been concerned about apparently deteriorating water quality in the lake as well as the high lake levels
- ▶ A preliminary study in 1999 suggested Whelp Creek water quality is of concern and agriculture has been implicated
- ▶ Lacombe County halted all diversions of Whelp Creek into the lake in 2008 and the county has been conducting tests to determine the background quality of the lake water with advice from Alberta Environment
