Indianfarm Creek Watershed News

Fall 2010

A SOIL BIOENGINEERING UPDATE!

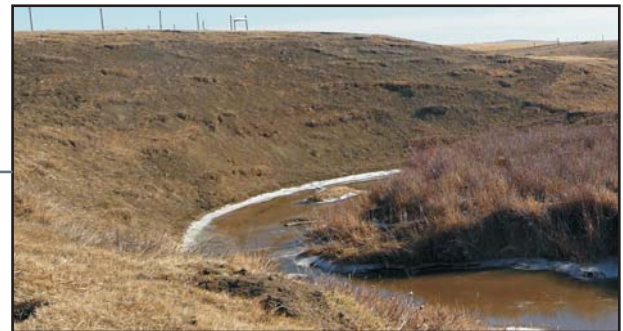
March 1 – selected site prior to project establishment

The Indianfarm Creek Watershed Group, in partnership with Alberta Agriculture and Rural Development and the Alberta Conservation Association, initiated two bioengineering projects on Indianfarm Creek this spring. The first project was completed in April on the main stem of Indianfarm Creek by Helping Hands Services, a contractor from Drayton Valley. Helping Hands Services installed sediment stops, which are biodegradable filtration systems made of a 70% straw and 30% coconut-fiber matrix and is reinforced with 100% biodegradable netting. This is rolled to create a highly effective, temporary, three-dimensional, sediment filtration system. Wattle fences, made out of wood board and live cuttings, were also installed during low flow this spring. The first project withstood the higher than normal precipitation amounts and high flow events this spring, and had great vegetative establishment success! However, a small area on the slope slumped causing some of the bioengineering structures to slide down slope. Also, the high flows caused some live cutting losses (which we hear the beavers downstream thoroughly enjoyed!). Grumpy's Landscaping Ltd. has been hired to repair these damages this fall.

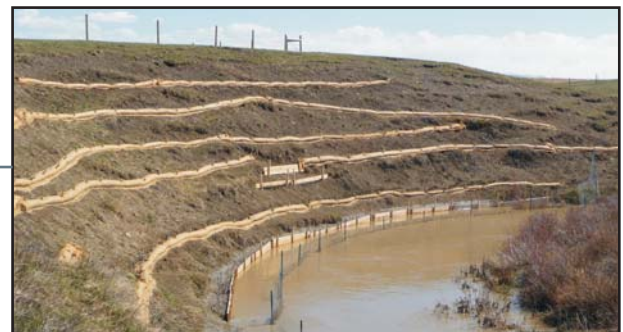
April 30 – live stakes were planted and a reclamation grass seed mixture was spread over the entire site – species used were red osier dogwood, willow, cottonwood and prickly rose

particularly those that are native to your watershed like red osier dogwood, willow, cottonwood and prickly rose. The cuttings need to be inserted into the soil in the spring when they have not budded out yet or in the fall after the leaves have fallen off. The cuttings used should be free of all branches, be cut to the diameter of your thumb width, and about 1 meter in length. They should be inserted into the soil (buds pointed up!) so that at least 3/4 of the cutting is underground. On drier slopes, 7/8 of the cutting should be inserted. You can plant them any way you like, vertically or diagonally as long as the cutting will remain moist over some of its length. In tougher soils, such as clays where it may be hard to plant the cuttings, you may trim the cutting to maintain the 3/4 or 7/8 burial, as long as the cutting is at least 40 cm (0.4 meters) long. For better success in establishment, soak your cuttings for a couple of days before you plant them. As the cuttings grow during the summer, the roots serve to bind the unstable stream banks which will lead to reduced erosion, stream sedimentation, improved water quality, and creation of wildlife habitat.

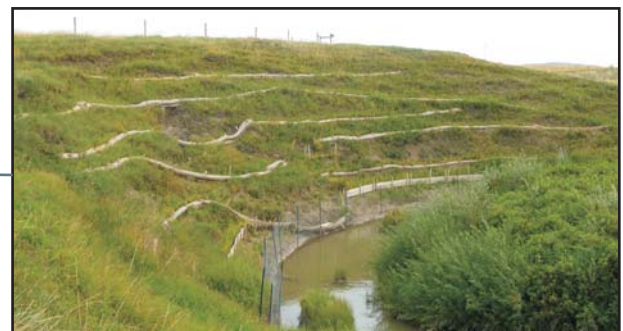
September 1 – vegetative establishment

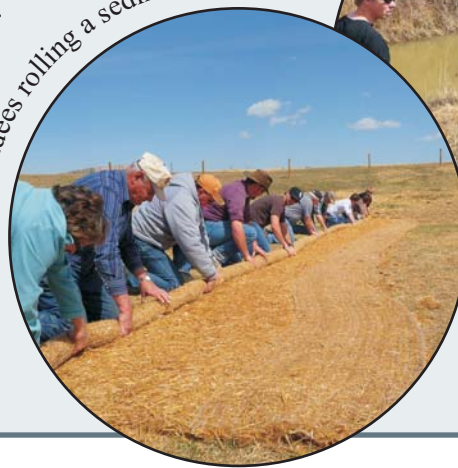
Attendees rolling a sediment stop

Alberta Agriculture staff, along with the knowledge of Helping Hands Services, hosted a Bioengineering Field Day earlier this spring. Approximately 12 members of the Indianfarm Creek Watershed Group attended and representatives from Alberta Conservation Association and Alberta Environment also participated. This group got to see soil bioengineering in action and participated in the preparation and installation of sediment stops. A special thank you goes out to Gordon Hoffman for allowing us to host the field day on his property!

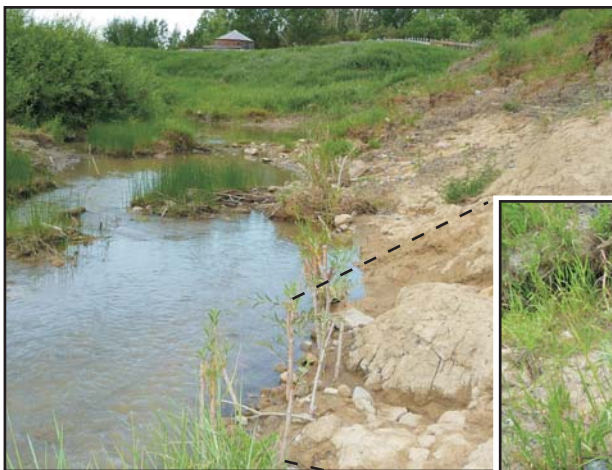
Example of an established live cutting

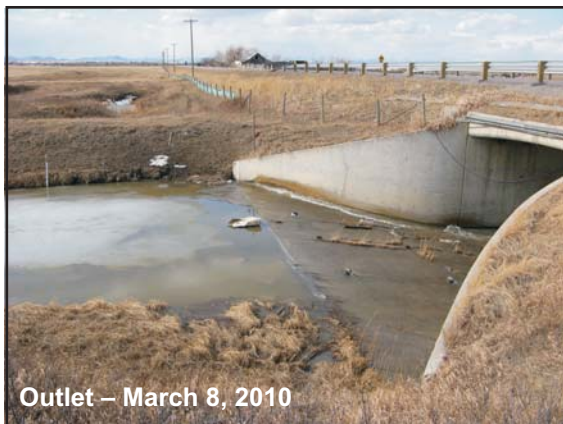
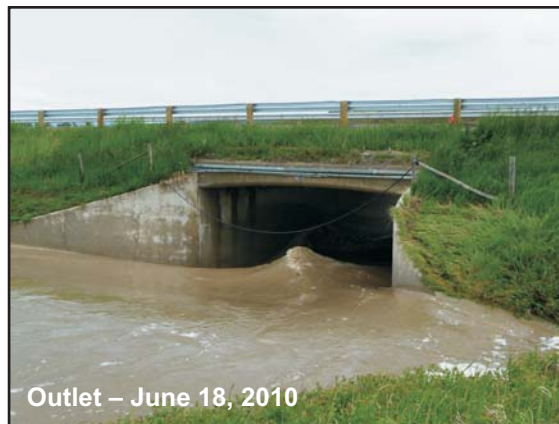
Indianfarm Creek outlet into Pincher Creek

Indianfarm Creek literally became a river during the June 2010 event. The flow in IFC peaked around midnight on June 17 with a water height reading of 227 centimeters. Flow metering on June 18th was done when the water level was at 130 cm and flow at this time was 37 cubic meters per second (m^3/s), which was approximately three times greater than the flow event in June of 2008. The rainfall runoff flows in the creek during this event were actually greater than during event base flows in the Oldman River near Brocket, e.g. the flow in the Oldman River was $27 m^3/s$ at 6:30 am on September 16, 2010 (Alberta Environment website, 2010). These flows were quite remarkable for a small agricultural watershed!

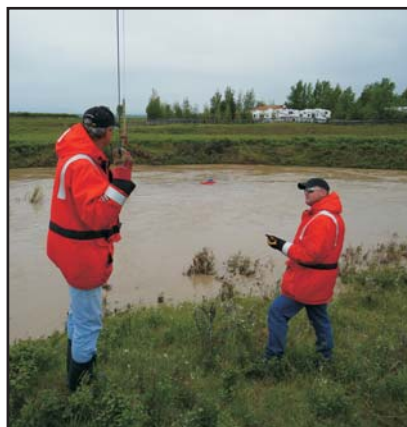
Flow metering on Indianfarm Creek
– June 23, 2010

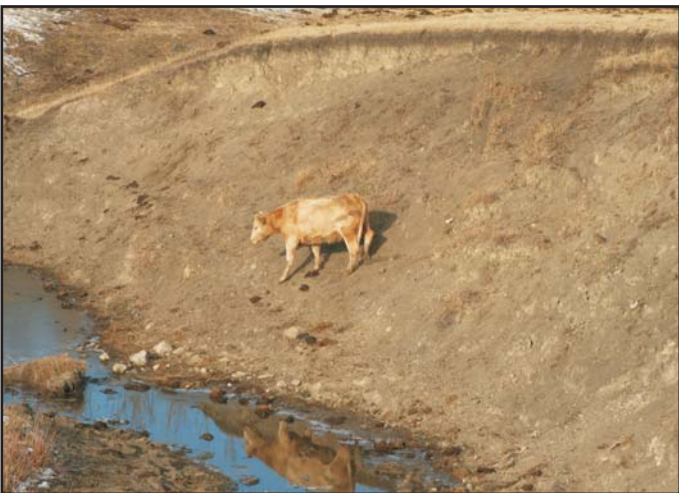
Excessive cattle grazing can exacerbate natural bank erosion, making it difficult for native vegetation to establish.

Controlling bank erosion in Indianfarm Creek is a challenge. Bank erosion is a natural process of all streams, but the degree of erosion varies based on stream characteristics. Erosion is a dominant process in foothills streams that have “flashy” flows and overgrazed riparian areas can exacerbate the erosion.
