Monitoring for Invasive Mussels in Alberta's Irrigation Infrastructure: 2017 Report

Alberta Agriculture and Forestry
Water Quality Section

January 2018

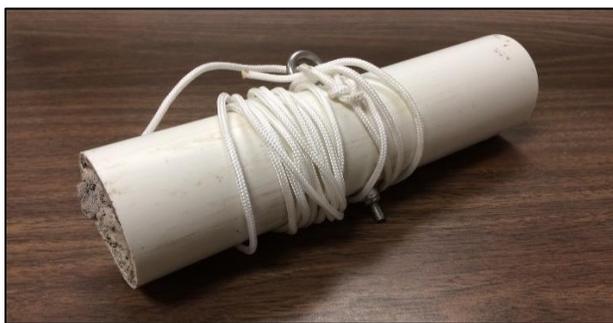
Figure 1. Artificial substrate.

Substrate monitoring. In 2013, artificial substrates, constructed of polyvinyl chloride (PVC) pipe and filled with cement, were installed in each reservoir (Figure 1). The substrates provide a solid surface on which invasive mussels, if present, can attach, and were installed near locations and infrastructure that were easy to access, and had high boat traffic, namely docks. Substrates were checked by visual and tactile observations each month from May through October. All submitted reports in 2013 to 2017 indicated no attached mussels.

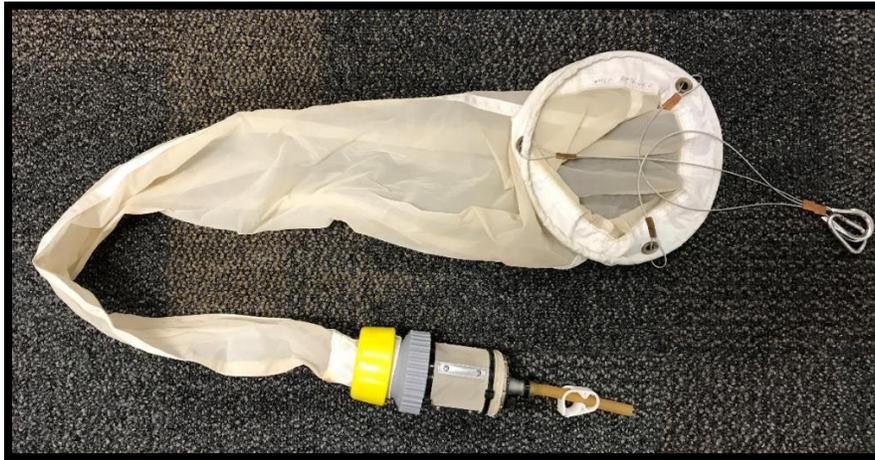
Figure 5. Plankton sampling net.

To support the expansion of the field sampling program, AF purchased three new custom plankton sampling nets from Wildlife Supply Company® (Wildco) for the 2017 veliger sampling season. The custom Wisconsin plankton nets measured 7.62 cm x 74 cm with a 63- μ m screen. The net filtered the sample into the Dolphin™ Bucket of with 100-mL volume and 63- μ m screen (Figure 5).

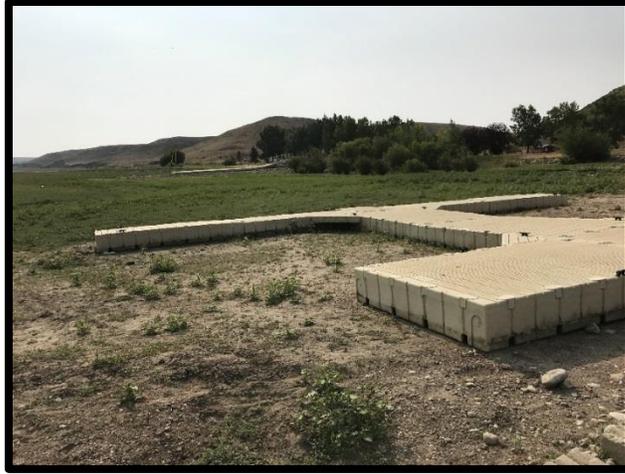
Figure 6. Chin reservoir boat launch and dock not sampled during the August 2017 sampling events, due to low water level.

However, challenges were still encountered during the 2017 field program. Site access to collect samples was a challenge at some locations such as Chin reservoir (Figure 6). Docks and boat ramps were chosen as sampling locations because it is assumed that such areas would be the first to yield a positive test for veligers (if present) due to high boat traffic. Sampling at docks and boat ramps was done by performing a horizontal sweep within the water column at 1 m above the bottom of the reservoir at shallow reservoirs (<5 m), and vertical tow at deep reservoirs (>5 m). However, 2016 and 2017 had minimal precipitation and warm temperatures during the summer months, and at times, the reservoir levels were so low that the docks became beached. Low water levels in the reservoirs cause low-flow conditions in the canals as well. Thus, the canal sampling protocol had to be modified again for 2017. Low-flow conditions limited the effectiveness of plankton sampling because insufficient current velocity prevented the net from staying open when submerged in the water current, thereby resulting in a non-representative sample. The new protocol made accommodations for low-flow conditions by including instructions for a horizontal upstream sweep. The horizontal upstream sweep was performed in low flows (<0.15 m/s) for low turbidity conditions (36 m), or high turbidity conditions (18 m). The use of the revised methodology in 2017 allowed for the successful collection of water samples from low-flow conditions. The protocol has been updated and provided to the irrigation districts for their use. Finally, the Swoffer flow meter malfunctioned at one instance during the monitoring program, as the water velocity of the outlet canal is required to determine the net submergence time it was measured using the float method. The malfunction was due to corrosion of the electrical contacts, maintenance and cleaning of the equipment remedied the problem.

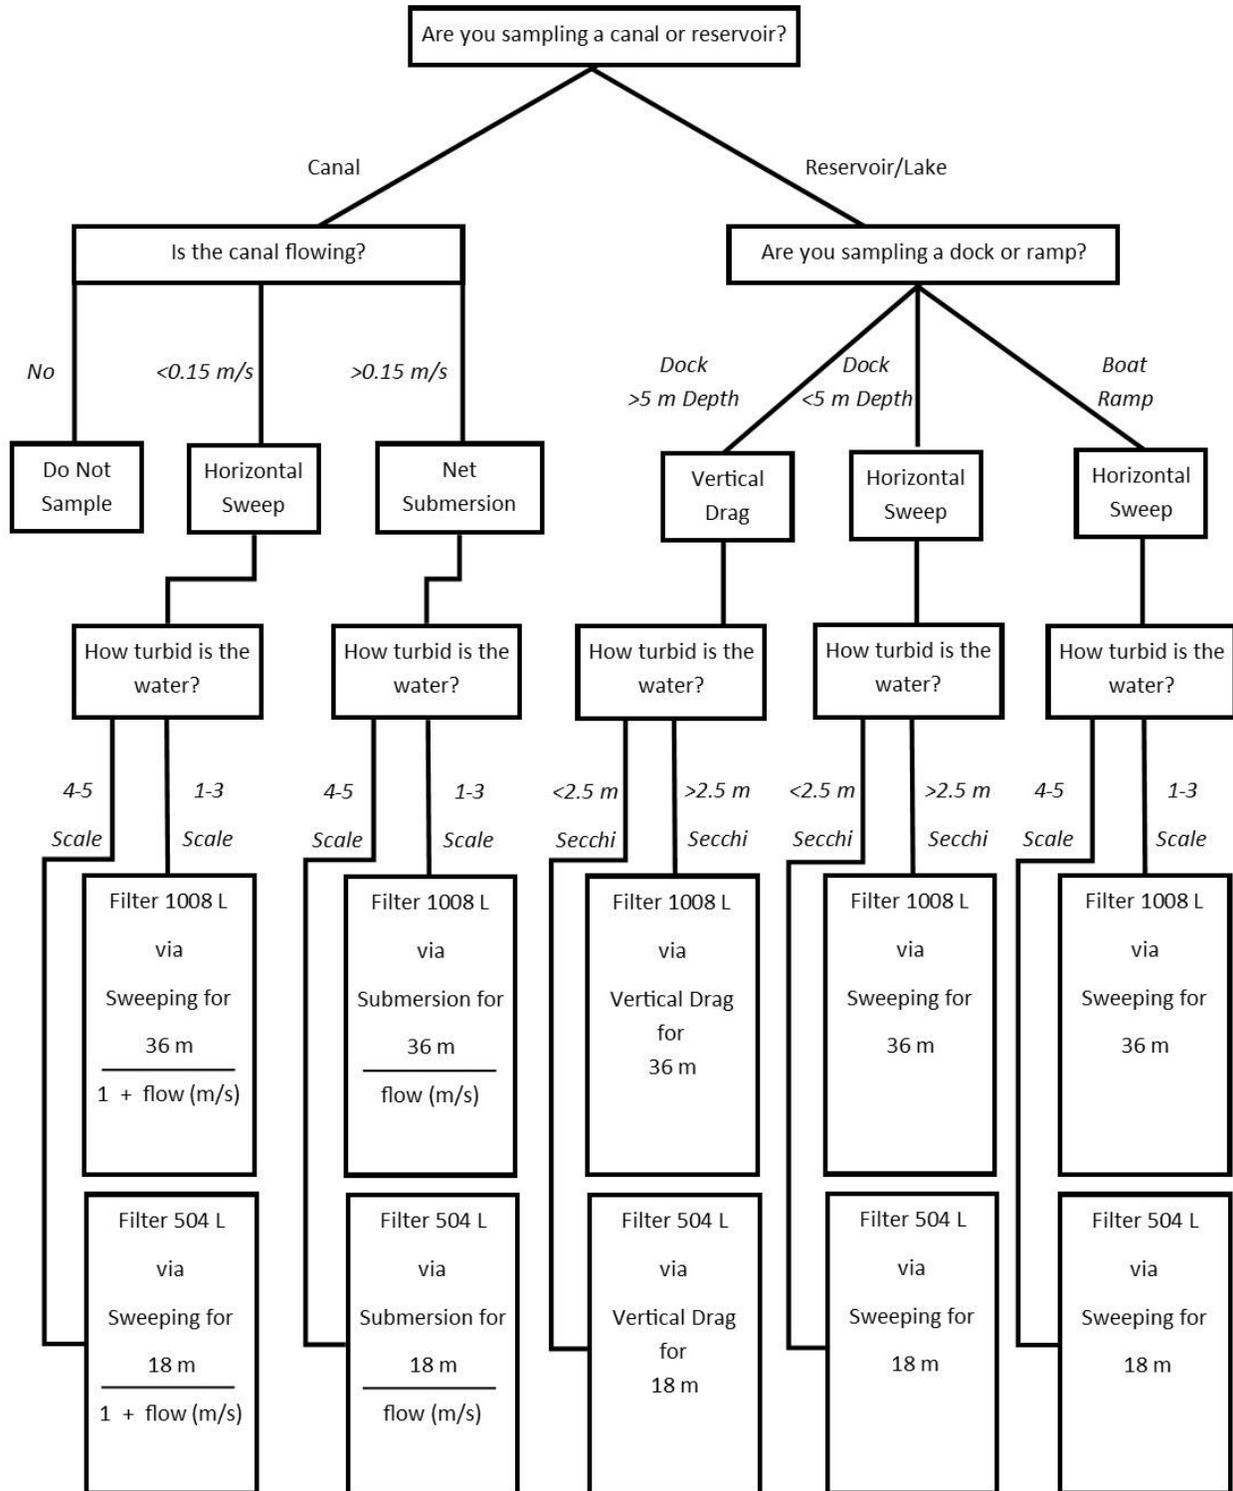
Appendix A.

Outlet monitoring protocol flowchart.
