## Crowfoot Creek Watershed Study

The Crowfoot Creek Study was conducted to determine whether agricultural practices are contributing to the deterioration of surface water quality in the watershed and to identify specific land uses having an impact. Water quality was monitored at 28 sites over a four-year period. Results indicated levels of total phosphorus exceeded water quality guidelines most of the time, but were highest during spring runoff. Levels of total nitrogen exceeded the guidelines mainly during spring runoff and rainfall events. Fecal coliform bacteria counts exceeded irrigation and contact recreation guidelines for much of the year and appeared to be related to the presence of cattle in the watershed. Guidelines for total dissolved solids were exceeded from spring runoff through early summer, and during rainfall events. Manganese and iron concentrations exceeded some guidelines during spring runoff. Of 25 pesticides monitored, dicamba, 2,4-D and MCPA appeared consistently and exceeded irrigation guidelines during part of the monitoring period.

**IB006-2000**

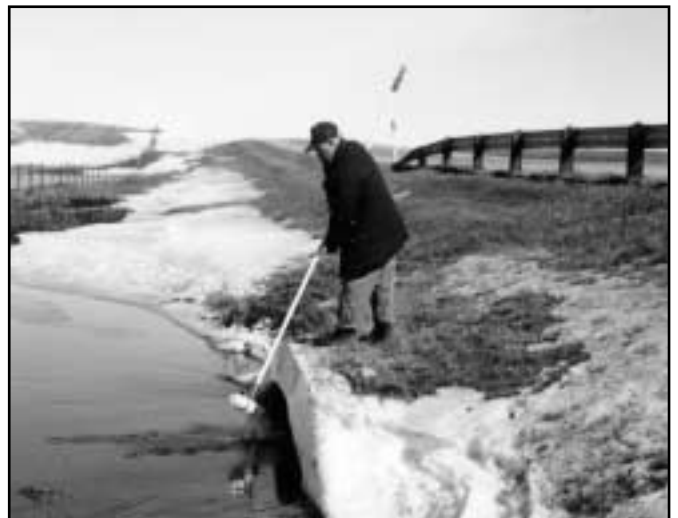
*A technologist collects a water sample at Site 19 on Crowfoot Creek during spring runoff 1997.*
