## 3 INDIANFARM CREEK WATERSHED

### 3.1 Introduction

#### 3.1.1 Watershed Description

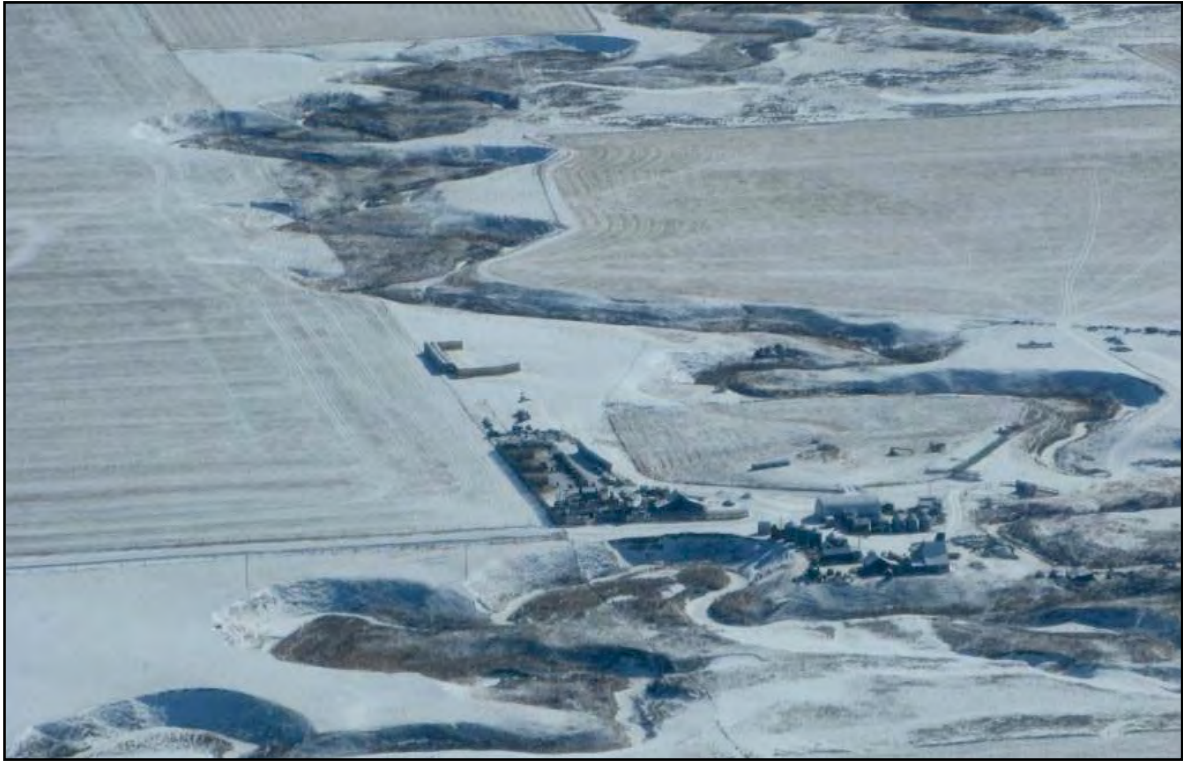
**Figure 3.14. Aerial view of the Indianfarm Creek mainstem with a narrow band of limited natural forage, which is surrounded by annual cropland.**

Tributaries of IFC in the lower region were often left as thin bands of grass or perennial forage surrounded by annual crops (Figure 3.14). These tributaries are areas of particular interest because of the proximity to annual crop land and the accompanying nutrient management practices used on the land. The aerial survey, along with the ground survey, showed that these tributaries generally were influenced by livestock, either through confined feeding or fall-winter grazing. The narrow grassed waterway is an obvious area for cattle to concentrate for forage and/or bedding. This can result in greater than normal manure concentrations as well as cause riparian degradation. The increased manure load and degradation of riparian zones can affect nutrient concentrations in spring snowmelt and rainfall runoff within the contributing areas.

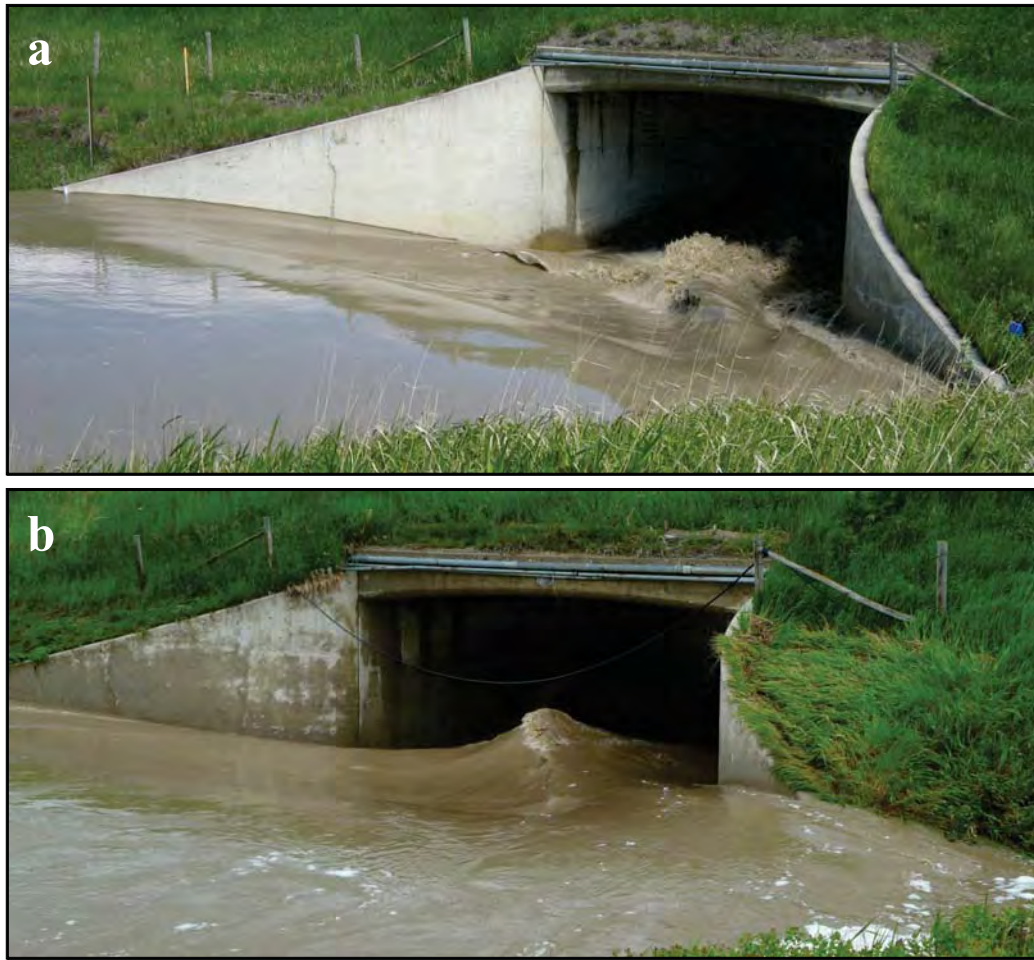
**Figure 3.18. The outlet on (a) June 12, 2008 and (b) June 17, 2010. The difference in flow between the two dates can be seen at the sides of the concrete structure of the road bridge.**

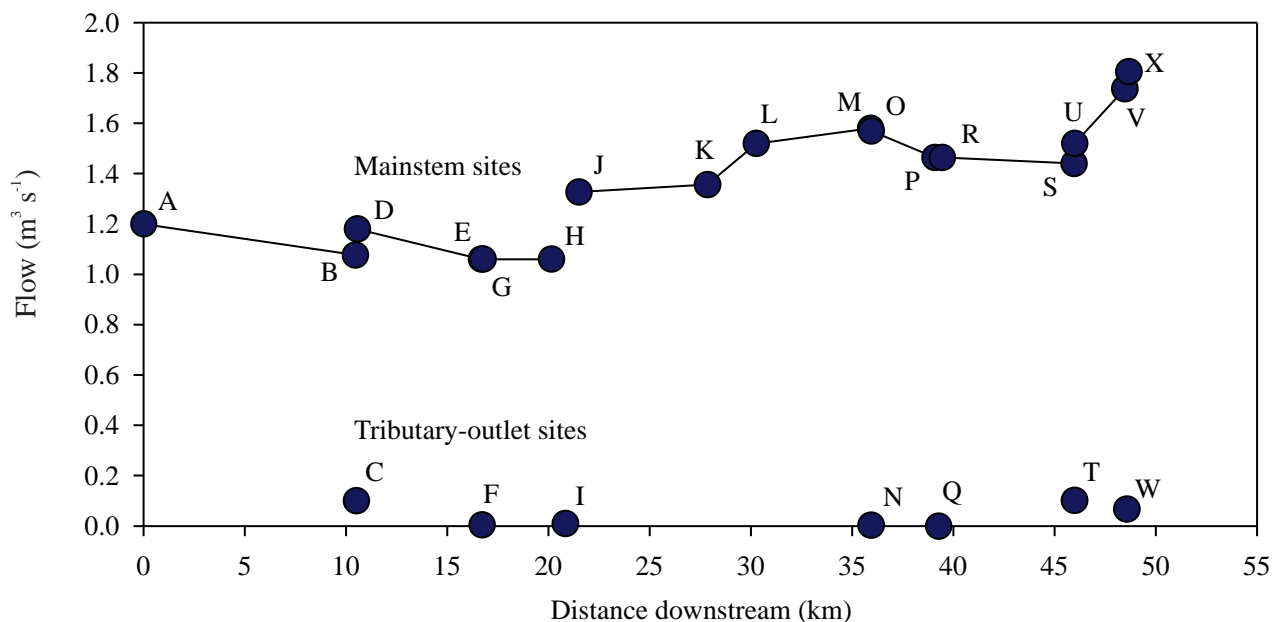
**Figure 3.32. Flow in Indianfarm Creek during the high-flow synoptic survey carried out from May 26 to 27, 2008 from the headwaters (Site A) to the watershed outlet (Site X). The gap in the flow (between Sites H and J) indicates the location of Therriault Dam.**

**Comparing low- and high-flow synoptic surveys.** The average flow among the mainstem sites for the high-flow synoptic survey was more than 100-fold greater than the average flow observed for the low-flow synoptic survey (Figures 3.27 and 3.32). The average flow for the tributary sites was 220-fold greater during the high-flow synoptic survey compared to the low-flow synoptic survey. The velocity of water in the mainstem was calculated at 0.7 km h<sup>-1</sup> upstream of the dam and 0.6 km h<sup>-1</sup> down of the dam during the low-flow survey (Tables 3.5 and 3.6). The velocity of water in the mainstem was calculated at 1.8 km h<sup>-1</sup> upstream of the dam and 1.2 km h<sup>-1</sup> downstream of the dam during the low-flow survey (Tables 3.5 and 3.6).

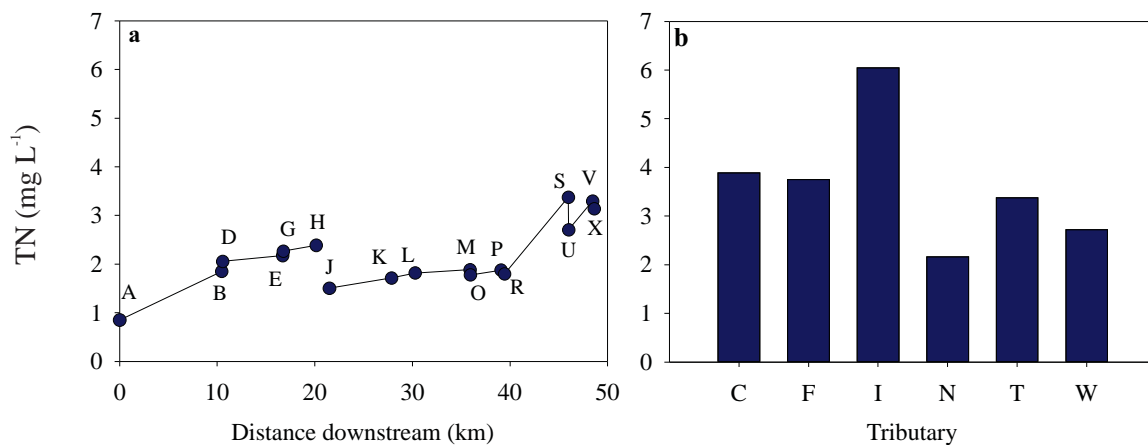
**Figure 3.33. Total nitrogen (TN) concentrations on the (a) mainstem of Indianfarm Creek and (b) tributaries during the high-flow synoptic survey carried out May 26, 2008. In Figure 3.33a, sites are arranged from upstream (Site A) to downstream (Site X). The gap between Sites H and J represents Therriault Dam.**

The concentration of TN and TP in the mainstem increased with distance downstream (Figures 3.33a and 3.34a). The increases in concentration were similar to average values found during the rainfall runoff watershed-wide data (Sub-section 3.4.2.2). In the reach upstream from Therriault Dam, the concentrations of TN and TP increased by about three-fold from Site A to Site H. At the watershed outlet (Site X), the concentration of TN was 3.7-fold greater and the concentration of TP was 6.9-fold greater compared to Site A. Total P concentration was similar immediately upstream (Site H) and downstream (Site J) of the dam ( $0.19 \text{ mg L}^{-1}$ ), and the overall increase in concentration was generally steady throughout the mainstem. In contrast, TN concentration decreased immediately downstream of the dam, suggesting the dam had a reducing effect on TN concentration. However, this was just a one-time sampling, and 6 yr of watershed-wide data did not support this effect of the dam (i.e., comparing Stations 19 and 16). Total N concentration then increased slightly from Site J to Site R followed by a large increase from Site R to Site S. The cause of the increase from Site R to Site S is unknown as there were no major tributaries flowing into IFC between these two sites.

Site I had particularly high TN ( $6.05 \text{ mg L}^{-1}$ ) and TP ( $1.36 \text{ mg L}^{-1}$ ) concentrations (Figures 3.33b and 3.34b). The Site I tributary was within a pasture area. The concentrations of TN and TP at tributary Sites C, F, I, and N were greater than at the respective upstream and downstream mainstem sites. In contrast, TN and TP concentrations were less at the tributary Sites T and W compared to their respective upstream and downstream sites. Therefore, it would be expected that contributions from Tributaries C, F, I, and N would have caused an increase in concentration in the

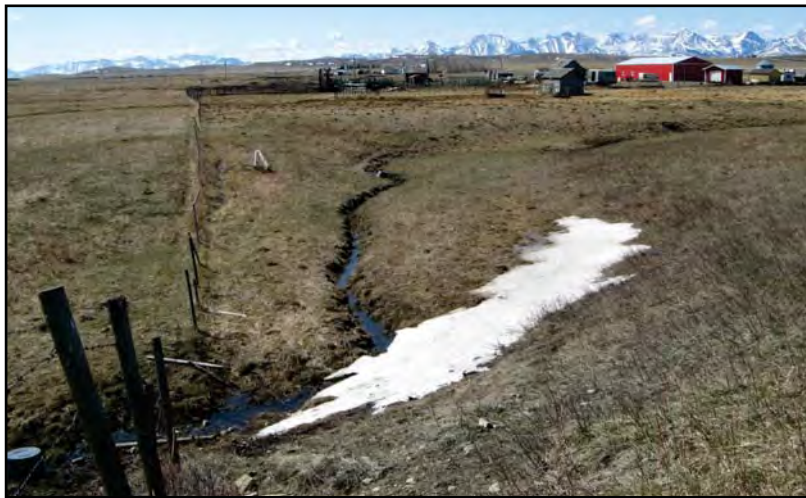
**Figure 3.37. Site F and tributary in a cattle pasture downstream from a farmyard. The outlet of the tributary into Indianfarm Creek was a few metres to the left of the image. Image taken May 1, 2008.**

Upstream from Therriault Dam, Sites F and I had the next two highest DPS values (Table 3.14). Tributary F flowed into IFC approximately 50 m upstream of Site G, while Tributary I flowed directly into Therriault Dam (Figure 3.15). Both tributaries may have been impacted by cattle activity. Sites F was in a livestock pasture and feeding area near barns and farmyard, and this area was significantly degraded (Figure 3.37). Tributary I was about 5 km downstream of a feedlot operation on the tributary. The results for Sites F and I, as well as for Stations 10 and 18, suggest that smaller, more vegetative drainage channels impacted by agricultural activity may have higher DPS values, compared to the larger, more defined creek channels. The mainstem and larger tributaries were scoured and flushed by larger flows, and this may have prevented the accumulation of sediment saturated with P in creek channels. The relatively low DPS of the sediments suggests the IFC channel is not a major source of desorbed P into the water; and as described previously, erosion and losses of PP are more of a concern in IFC Watershed.

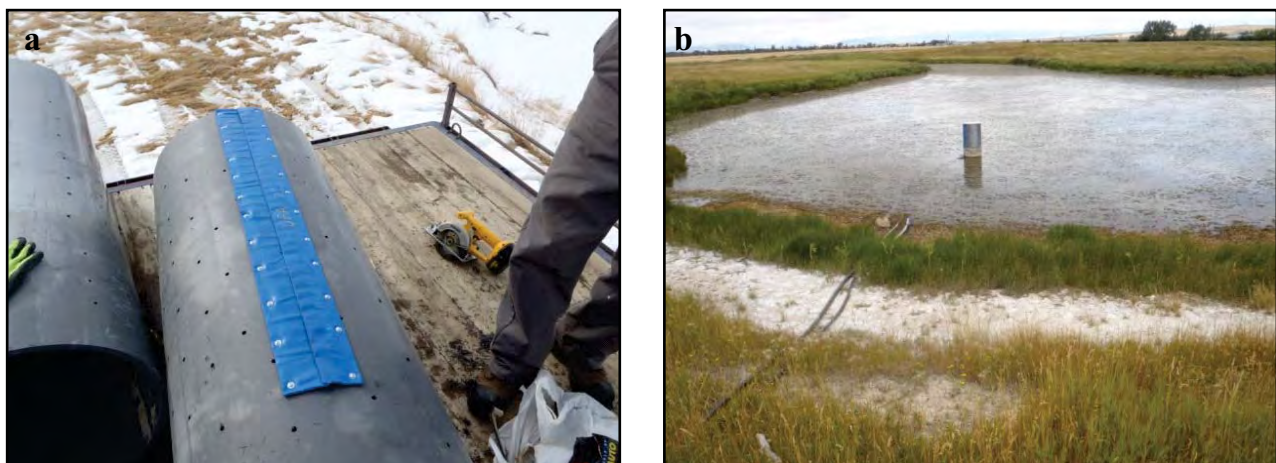
**Figure 3.39.** The PVC pipe used to house the water pump showing the (a) covered vertical slot and (b) its deployment in the Impoundment lake.

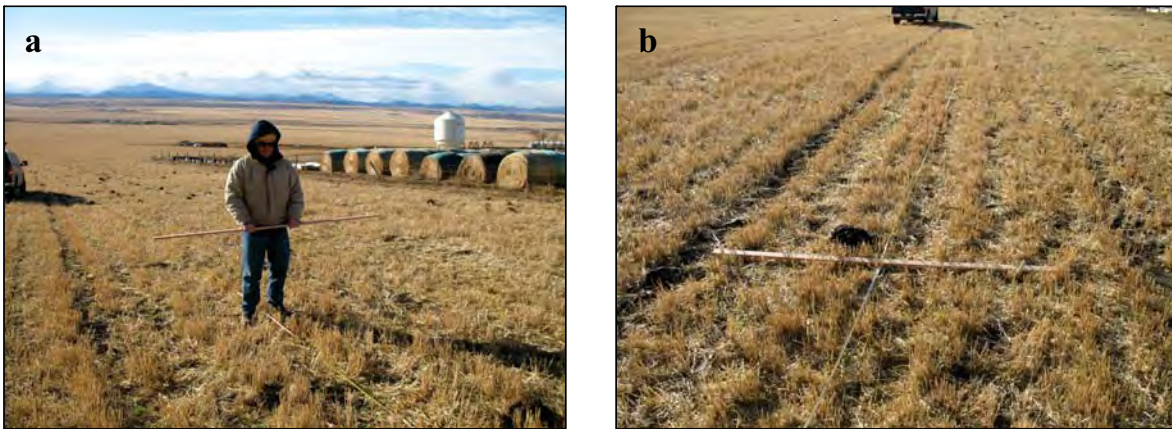
**Figure 3.54. Fecal pat counting by (a) walking along a tape measure with 2-m stick and (b) a view of the transect at Hotspot 6 with measuring stick in November 2009.**

and a second person recorded the numbers (Figure 3.54). Counts were converted to a density and expressed as pats per hectare.

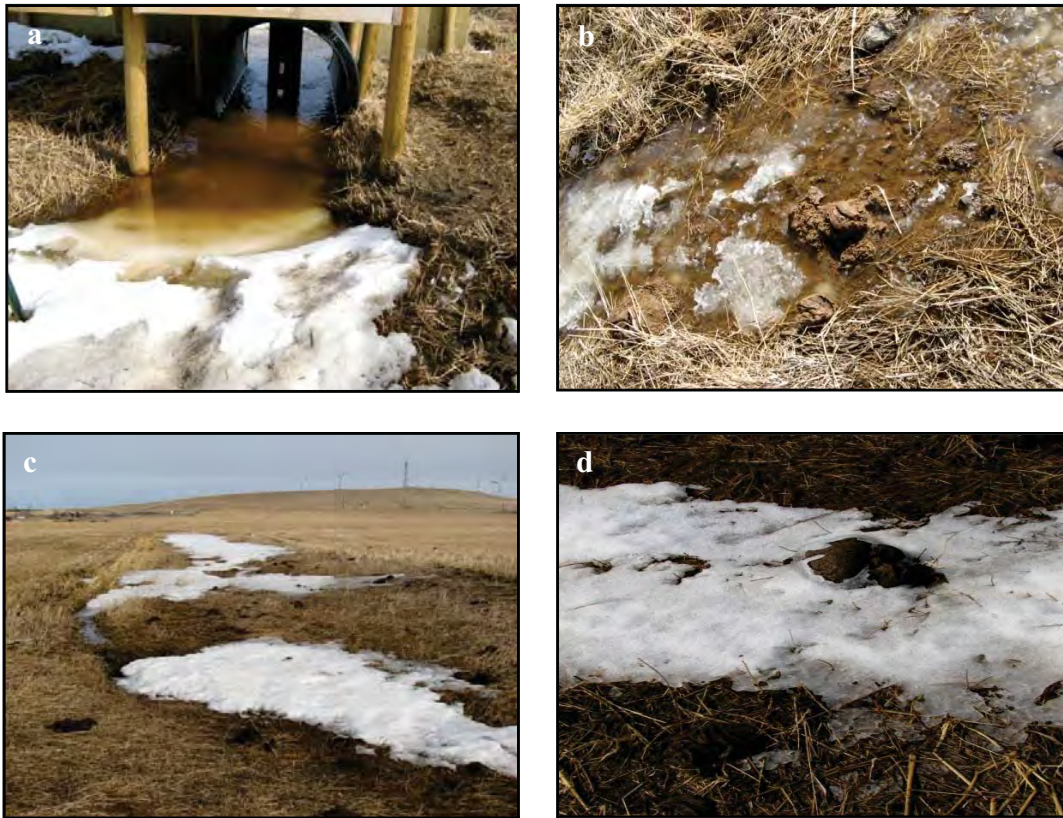
**Figure 3.64. Snowmelt runoff water and manure in the drainage channel upstream of the monitoring station on (a,b) March 14, 2009 and (c,d) March 3, 2010.**

Excluding cattle from the drainage channel in fall 2010 was effective in improving the quality of runoff water from the field. However, this was based on only 1 yr of post-BMP monitoring. Cattle grazing in the fall 2011 deposited fresh fecal pats in the drainage channel. The fecal pat density in the channel in 2011 was about 35% less than in 2009 (Table 3.30), likely due to the smaller herd in 2011 compared to 2009. Unfortunately, runoff did not occur in spring 2012. If runoff had occurred in 2012, we predicted an increase in concentration of many parameters in runoff compared to the 2011 results would have occurred. A high density of cattle fecal pats in a drainage channel intuitively would likely impact negatively the quality of runoff water (Figures 3.58 and 3.64).

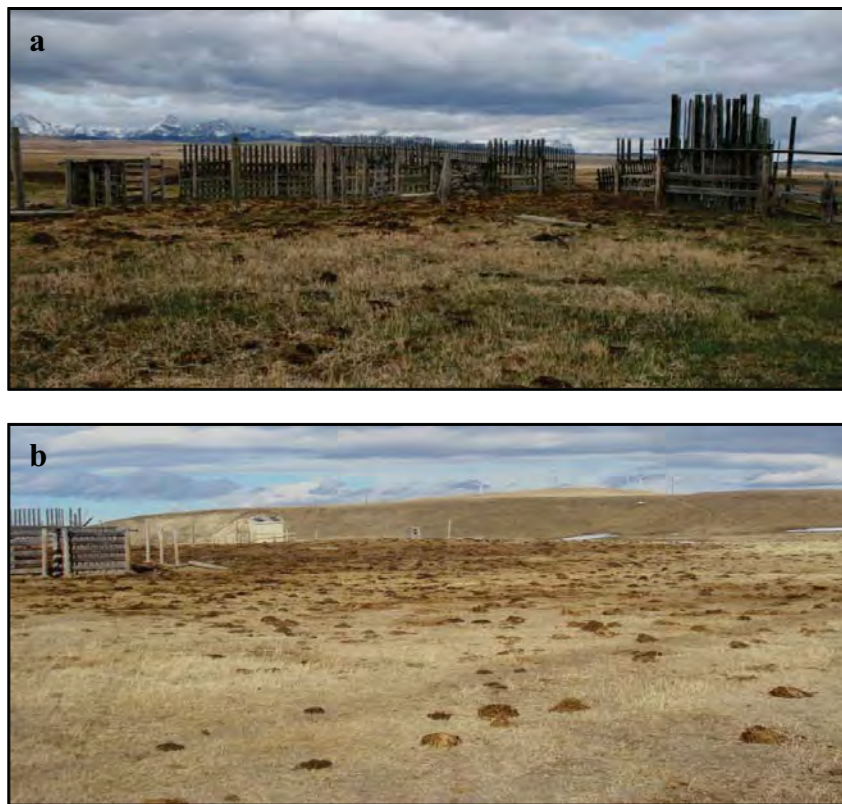
**Figure 3.67. The corrals in Pasture A showing the (a) manure pack in April 2007 and (b) the nearby accumulation of fecal pats in March 2009.**

Removal of the old corrals in Pasture A (Figure 3.67a) was done on August 6, 2009 (Figure 3.68b). Removal of the manure pack and re-vegetating the site was also considered. However, the site was stable with existing vegetation and it was felt that removing the manure pack would expose the site to soil erosion until the vegetation re-established. Therefore, the manure pack and existing vegetation were left intact.

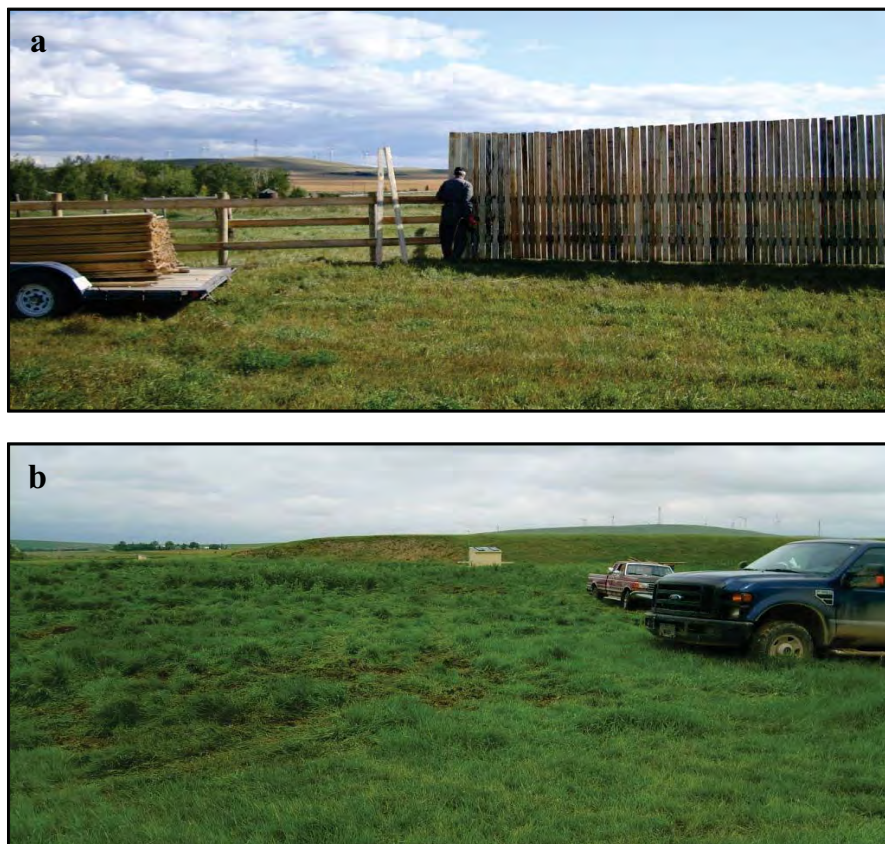
**Figure 3.68. Installation of the (a) permanent windbreak in September 2009 and the (b) corral site after the removal of the corral structure in early August 2009.**

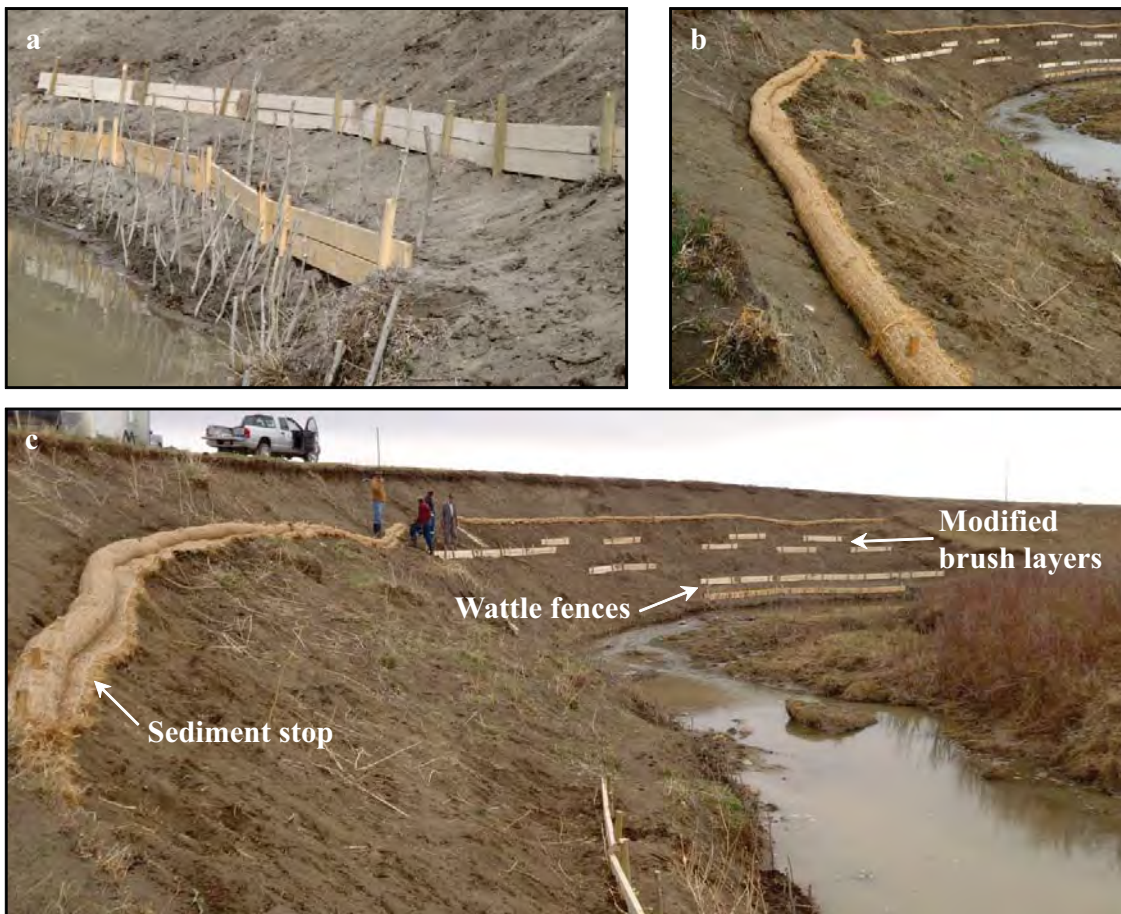
**Figure 3.71. Bioengineering installation at the Pasture site showing (a) wattle fence, (b) sediment trap and modified brush layers, and (c) the whole bioengineered site on April 26 and 27, 2010.**

Bioengineering techniques were applied to an eroded bank of IFC at the PST site in an attempt to stabilize and reclaim the bank. A 100-m stretch along the east bank of IFC was selected near the north end of Pasture A (Figures 3.69 and 3.71). The stretch was highly erodible during high flows and rainfall runoff events, and it was affected by direct cattle access (i.e., pugmarks and cattle

In April 2010, three wattle fences made out of wood boards were installed starting at low water level (Figure 3.71). To create the wattle fences, wood stakes (1.22 m long) were pounded into the slope as deep as possible and two boards were nailed vertically to the stakes along the length of the

fence. Soil was then back-filled onto the fence creating a 2:1 slope above the wattle fence. Approximately 400 live stakes were then planted in front and behind the fences (Figure 3.71a) using the same method described for the IMP site (Sub-section 3.5.2.4). Ten modified brush layers were constructed upslope of the wattle fences (Figure 3.71b,c). These brush layers were modified because they did not have live cuttings. Instead, wood boards were laid vertically across the slope and held with two wood stakes. Soil was then back-filled and packed behind the brush layer. These structures were used to slow the movement of soil and water down slope. Sediment stops were placed further upslope of the brush layers and were made of 100% bio-degradable coconut fiber and straw (Figure 3.71b,c). The sediment stops were rolled tightly and put on an area of the slope that was landscaped as flat as possible. Wood stakes (0.61 m long) were pounded directly into the rolls to hold them in place. Sediment stops were used to stop the movement of soil downslope and act as a filtration system by collecting sediment from water as it passed through the stop. A land reclamation seed mixture was spread on the entire site with a belly-grinder style grass seeder. The seed mixture contained 25% fleet meadow brome grass (*Bromus biebersteinii*), 20% sheep fescue (*Festuca saximontana*), 15% slender wheatgrass (*Agropyron trachycaulum*), 15% western wheatgrass, 15% green needlegrass (*Stipa viridula*), and 10% carnival tall fescue (*Festuca arundinacea*).

The IFC watershed received high precipitation during the springs of 2010 and 2011 (Sub-section 3.2.2). This created high creek flows and saturated soils, which were detrimental to the bioengineering installations. The first bioengineering installation was completed in April 2010 (Figure 3.71c). Then 60 mm of rain fell in late April, 110 mm in 5 d at the end of May, and 126 mm in 2 d during mid-June. Although the structures were repaired several times during this period, the rainfall event in June washed away most of the structures (Figure 3.75).

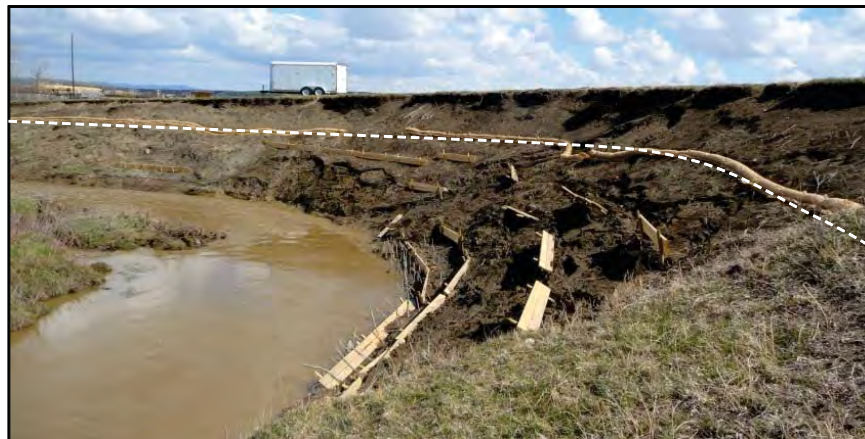
**Figure 3.75. Damage to the bioengineering structures installed in April 2010. The dotted line shows approximately the high water level during peak flow.**

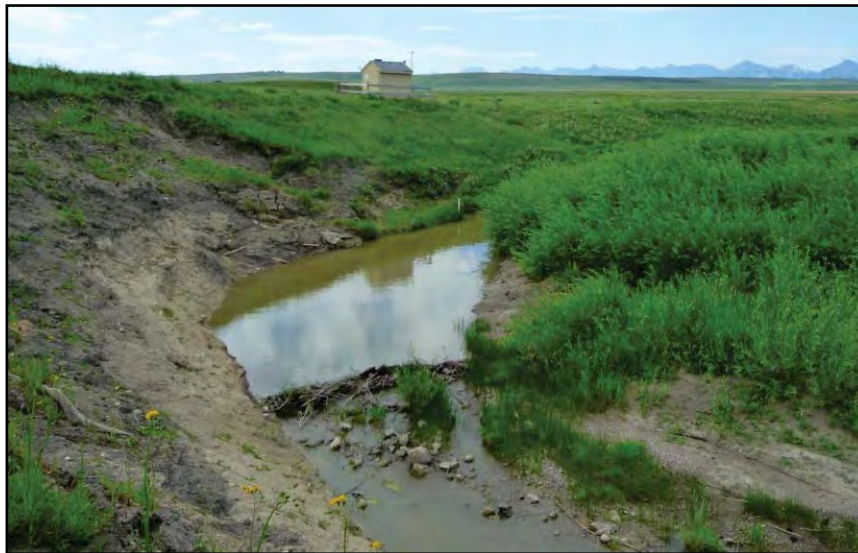
**Figure 3.82. Beaver dam downstream of Station 5 on July 29, 2010.**

Although many parameters changed little between the two instream monitoring stations, TSS concentration decreased during base flow from upstream to downstream by 36% in the pre-BMP period and by 37% in the post-BMP period (Table 3.54). Similar decreases were also observed during snowmelt. Several beaver dams were observed in the reach between Stations 5 and 8 (Figure 3.82) during the post-BMP period, and these dams created small pools of water. Sediment likely settled in these ponds during low flow.

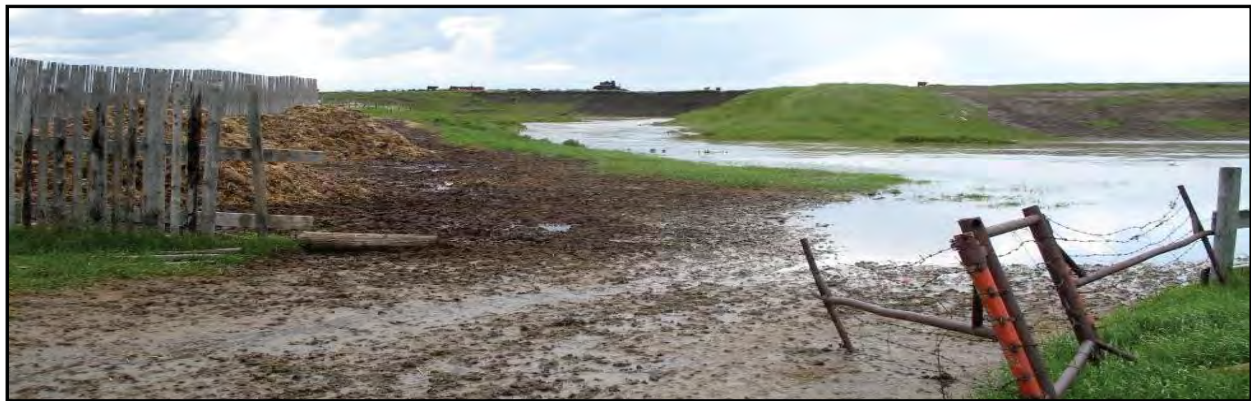
**Figure 3.84. The wintering bedding and feeding site adjacent to Indianfarm Creek during spring 2008 prior to the implementation of the beneficial management practices plan.**

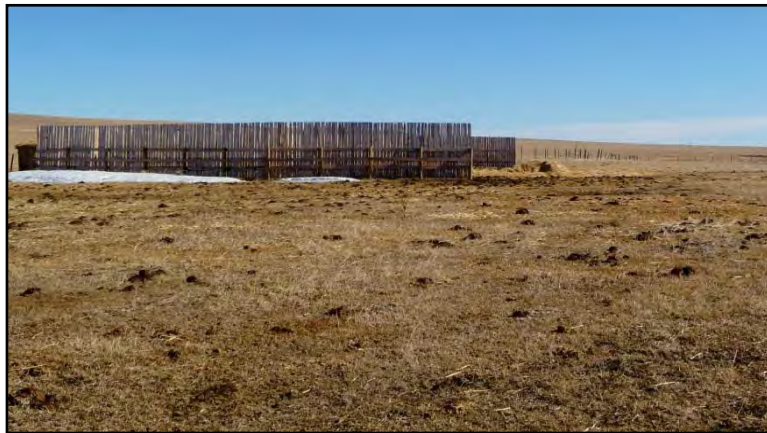
**Figure 3.86. The wintering bedding and feeding site constructed in 2008.**

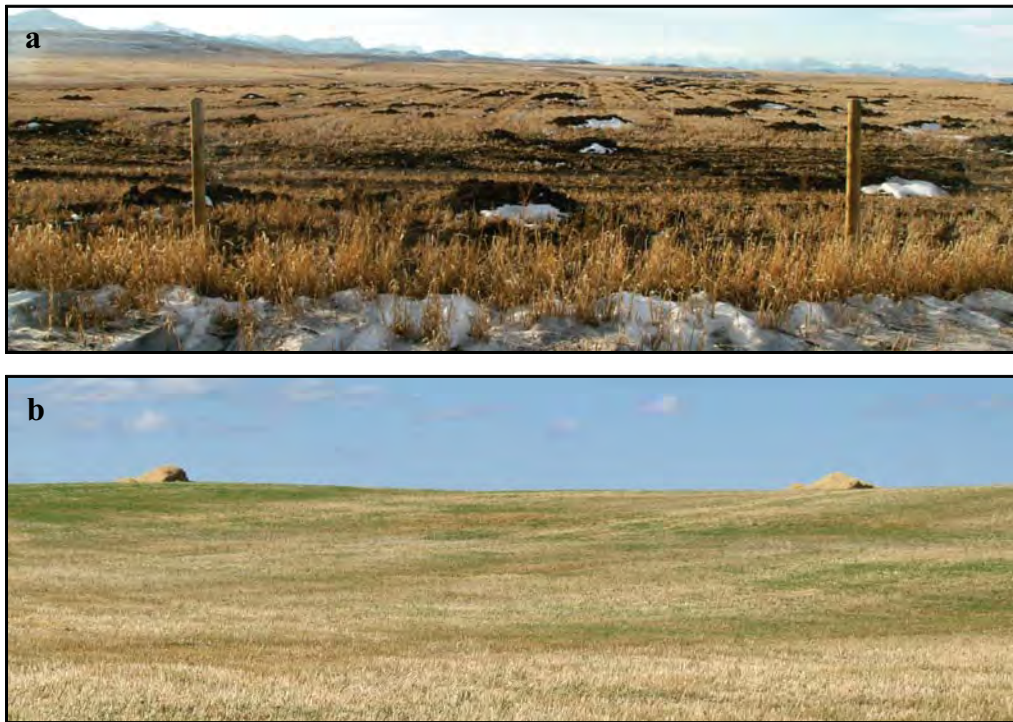
Figure 3.94. The field on the north side of the tributary at the South Manure Field showing (a) manure piles in fall 2006 and (b) chaff piles in fall 2008.

Solid cattle manure was usually applied once every 3 to 4 yr at the site. Manure was last applied to the north field in fall 2006 and was not applied again on this side of the drainage channel during the study. In 2006, manure was applied in small piles throughout the field (Figure 3.94a) and leveled with a cultivator by skimming the surface without incorporation. In 2008, manure was stockpiled in the northwest corner of the southwest quarter section, and was within the far southern

Cattle typically fall grazed in the fields after harvest. A barbwire fence along the south side of the tributary was used to manage cattle between the north and south sides of the tributary. In 2008, 140 head of cattle grazed on the north side of tributary from October 18 to November 18. Piles of chaff, which is the crop residue remaining after thrashing, were left in the field (Figure 3.94b) and water was provided from a dugout east of Station 18 (Figure 3.93). The dugout was fenced and cattle had access to water from a trough with a solar powered pump. In 2009, 78 head of cattle grazed from November 6 to December 2. Fall grazing by cattle did not occur in 2010 because of early snow and wet conditions. In fall 2011 and early 2012, cattle were grazed in the north field. Extended grazing was practiced using hay bales that were unrolled in swaths in the field (Figure 3.95a). A portable windbreak was also placed on the north side of the tributary between the two monitoring stations (Figure 3.95b). Bedding that was applied at the windbreak was removed with manure and stockpiled nearby.

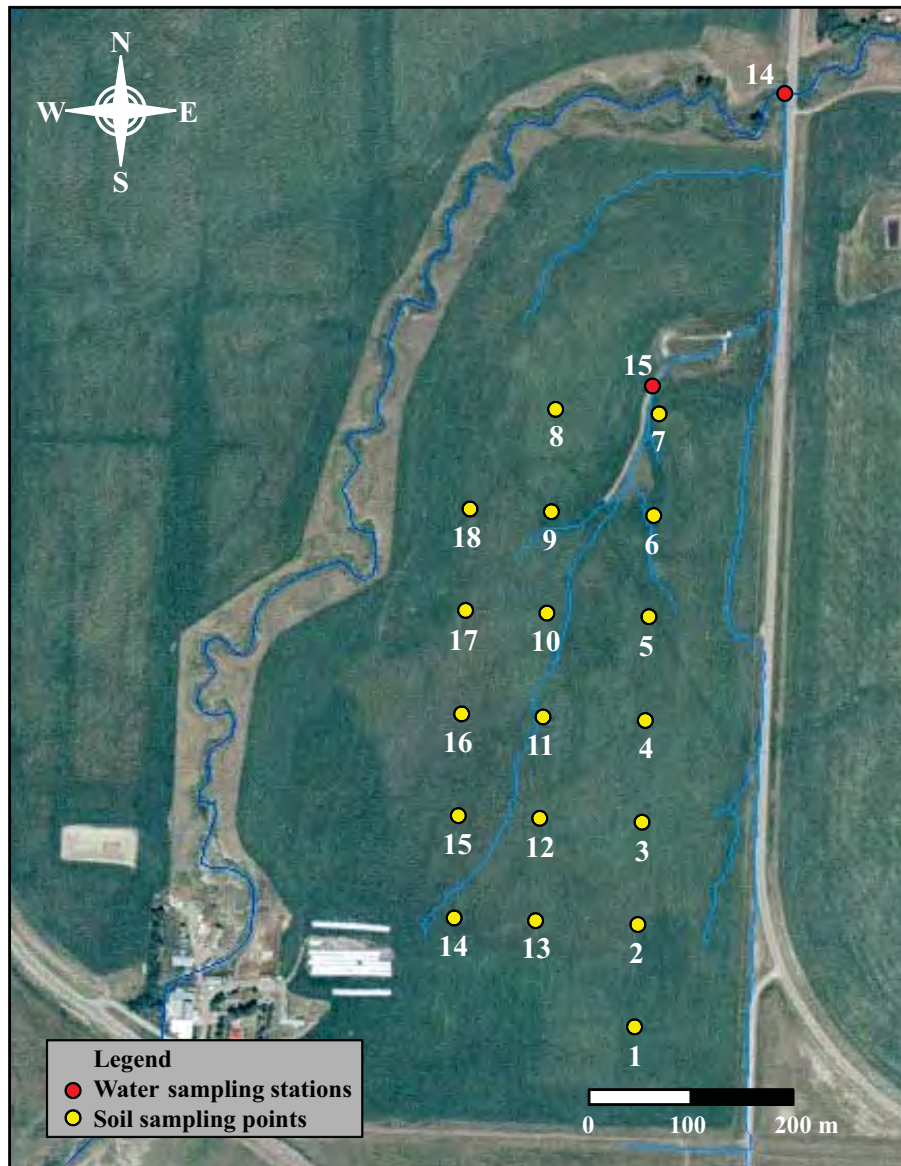
Figure 3.104. Agronomic soil (0 to 15 cm) sampling points at the Dairy Manure Field.

Soil characterization samples (Sub-section 2.9) were collected on October 16, 2008. Agronomic samples (0 to 15 cm) were collected at this site annually from 2007 to 2012. The agronomic samples were collected on a 100- by 100-m grid, which was different from the 200- by 200-m grid used at other BMP sites. The smaller grid size was used at this site because manure was applied to only a small portion (about 1 ha) each year. The sampling grid covered the drainage area and some of the surrounding area (Figure 3.104).

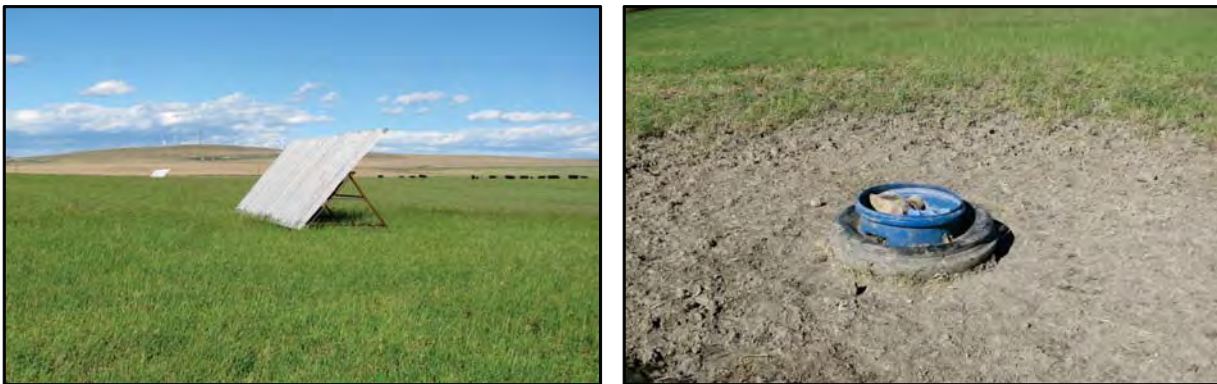
**Figure 3.111. Portable windbreaks (left) and a salt block (right) at the Reference site in late September 2010.**

Two portable windbreaks (2.6 m high by 9.3 m long) and salt blocks were placed in the field during fall grazing from 2009 to 2011 (Figure 3.111). These cattle distribution tools were used to attract cattle away from the drainage channel. The windbreaks and salt blocks were placed at different locations within the field each year.

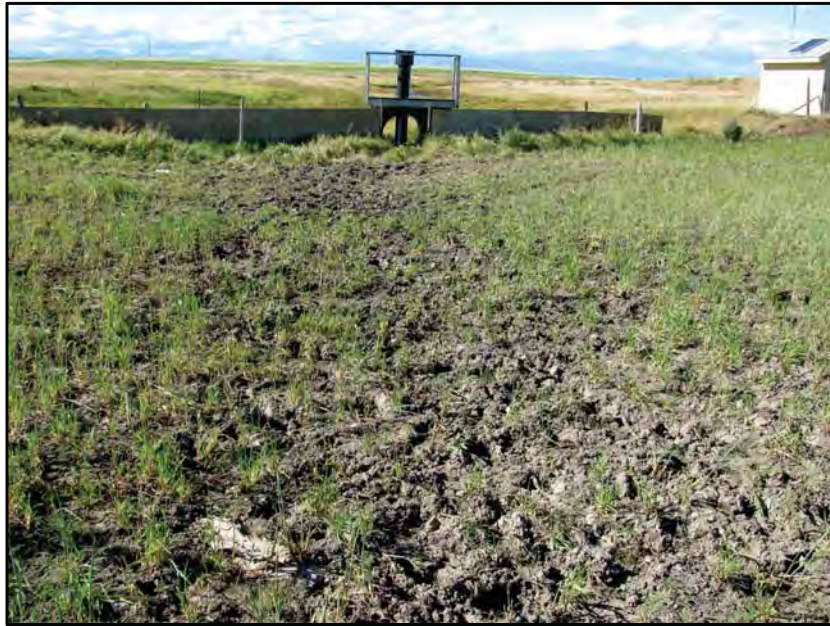
**Figure 3.112. Pugmarks in the drainage channel caused by cattle prior to deployment of the electric fence to cordon off this area in September 2010.**

To prevent cattle from using the water monitoring station for shelter and to keep the cattle out of this part of the drainage channel, an area 20 m wide and 30 m upstream of the monitoring station was cordoned off with an electric fence each fall from 2009 to 2011. In September 2010, cattle were placed in field 12 d before the electric fence, windbreaks, and salt blocks were deployed. As a result, cattle were able to access the channel immediately upstream from the monitoring station during the first 12 d of the 72-d period they were in the field (Figure 3.112).

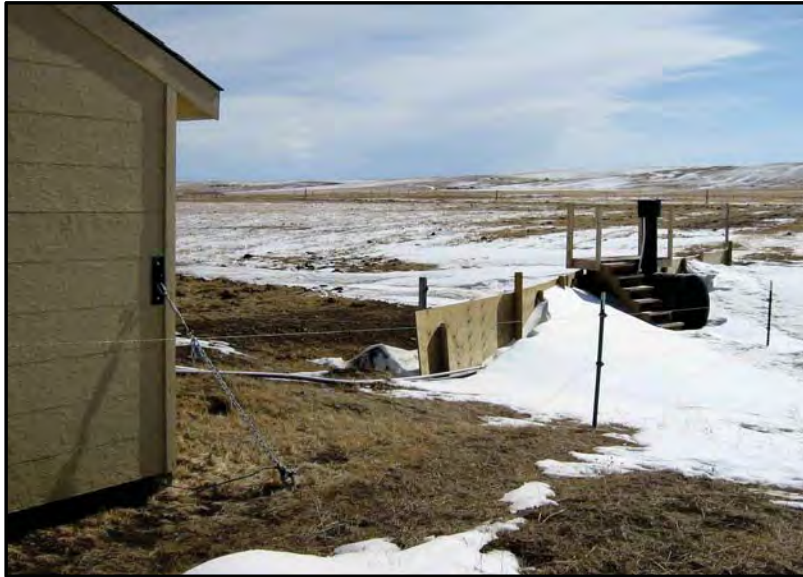
**Figure 3.113. Station 21 at the Reference site on March 13, 2009.**

This site was equipped with a single, edge-of-field water monitoring station (Station 21), which included a circular flume, automatic Isco water sampler, wooden wing walls to direct runoff, and an instrumentation shed (Figure 3.113). Station 21 was installed in fall 2007 and 5 yr (2008 to 2012) of runoff events were monitored at this site. The monitoring station was near the southwest corner and along the west side of the field where the 19-ha drainage area exited the field (Figure 3.109). An electric fence was erected around the station to protect it from cattle in the west pasture. Pre-BMP water samples were collected in 2008 and 2009 and post-BMP samples were collected from 2010 to 2012. A total of 17 snowmelt runoff samples and 16 rainfall runoff samples were used to assess water quality at this site.

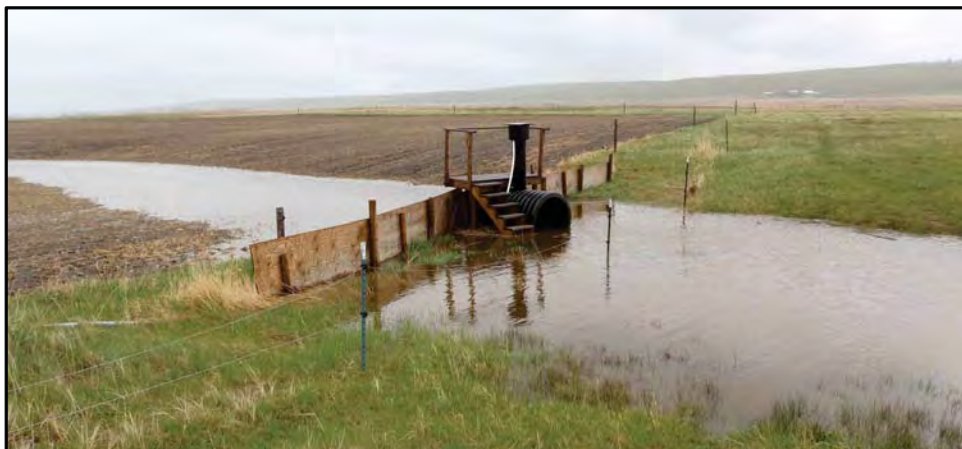
**Figure 3.114. Station 21 flooded with backed up water from the tributary on May 24, 2011.**

In 2010 and 2011, heavy rainfall events caused water from the tributary to back up into the circular flume (Figure 3.114). Therefore, rainfall runoff flow could not be measured and water samples collected by the Isco sampler were considered contaminated by the tributary water and these samples were not used. However, grab samples were collected during rainfall runoff from the field drainage channel about 20 m upstream from Station 21 where active runoff from the field was not affected by the water from the tributary.

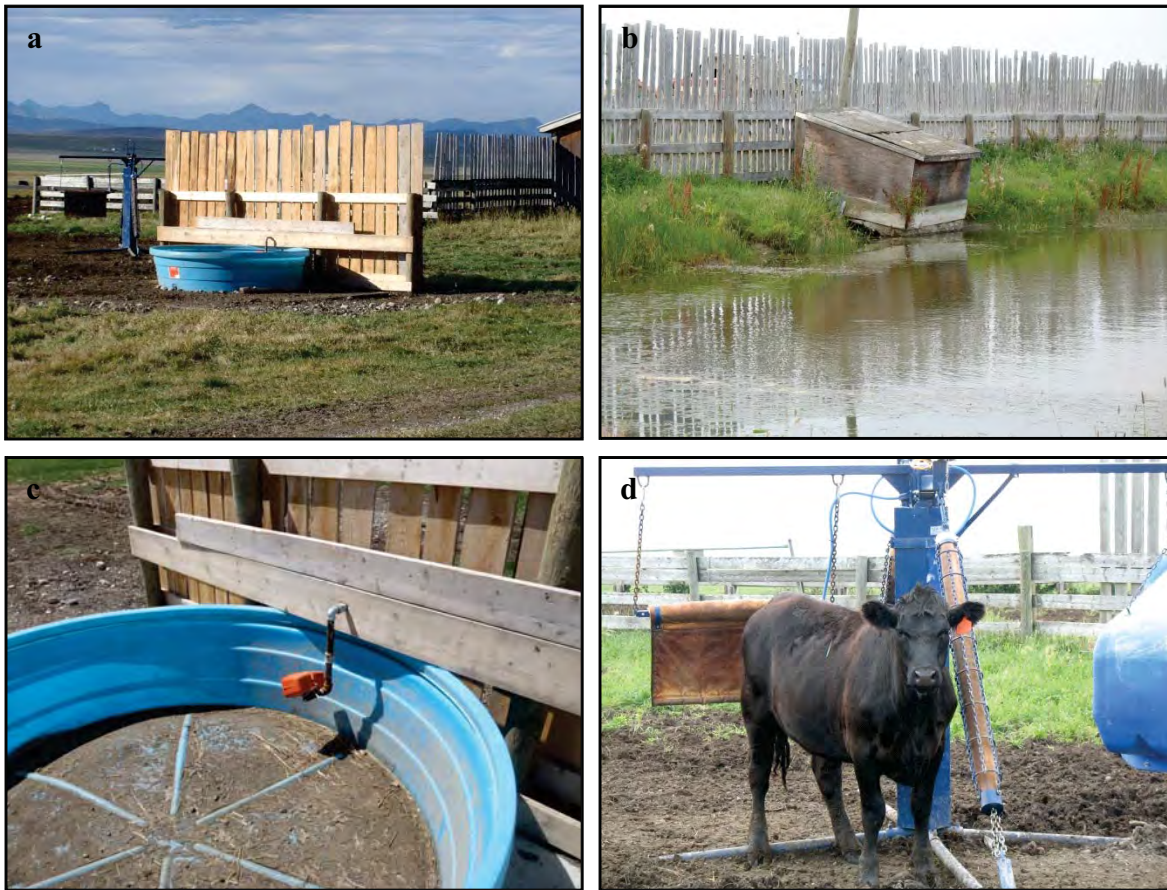
**Figure 3.121.** Images showing the (a) completed watering system and wind fence on October 7, 2010, (b) dugout pump shed, (c), water inlet to the trough, and (d) the cattle oiler.

The off-stream watering system was placed about 20 m south of the dugout, 23 m east of the nearest farm building, and about 100 m north of an access point on IFC (Figure 3.119). The off-stream watering system was placed at this location to attract cattle away from the access point on IFC (Figure 3.120b) and reduce the impact to the riparian area. The off-stream watering system included a concrete pad, a 2340-L trough, and wooden wind fence on the west side of the trough (Figure 3.121a). Water for the trough was supplied from the dugout through a pressure water line from an existing pump at the dugout (Figure 3.121b,c). Also, a cattle oiler was placed near the trough (Figure 3.121d) to help move the cattle out of the riparian area. The installation of the off-stream watering system and repairs to the dugout fence began in summer 2010 and were completed by mid-August 2010. In July 2012, a cattle feeder was placed a few metres south of the water trough, and the feeder was used to supply feed pellets.

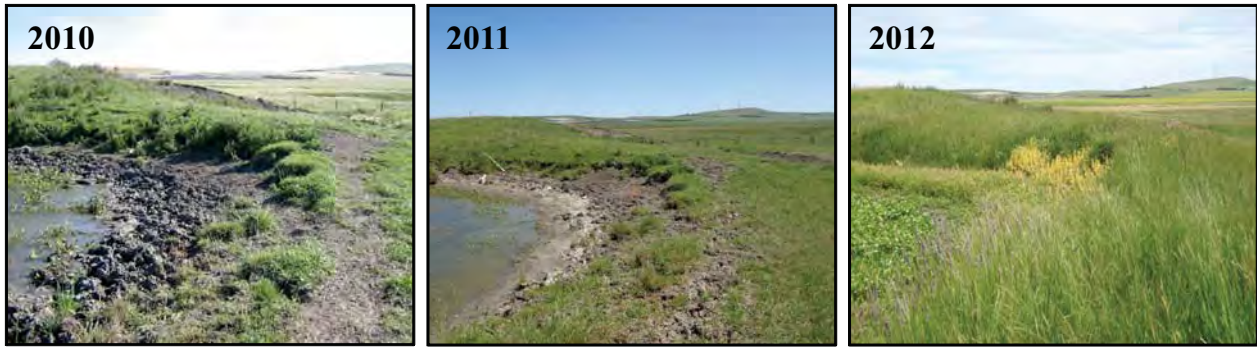
**Figure 3.122. Dugout photo-point images taken from Pin C at the Off-stream Watering site on August 26, 2010; July 7, 2011; and July 17, 2012.**

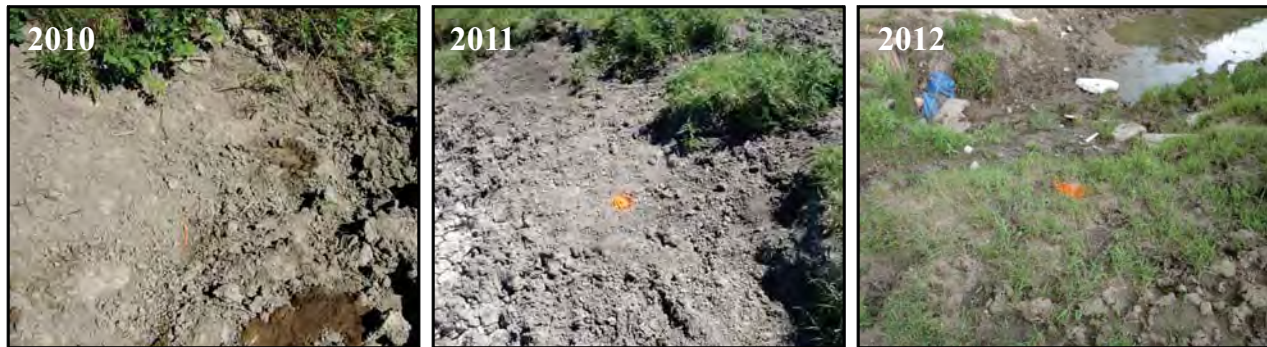
**Figure 3.123. Indianfarm Creek access area photo-point images taken from Pin B at the Off-stream Watering site on August 26, 2010; July 7, 2011; and July 17, 2012.**

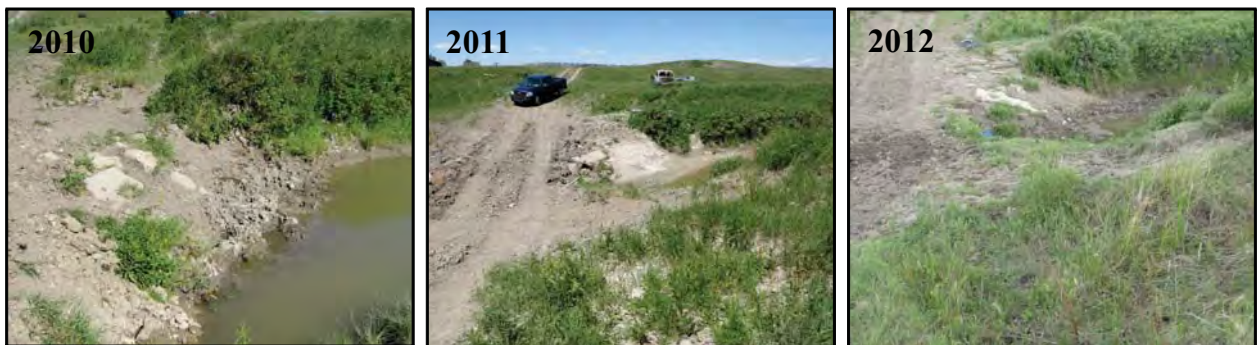
**Figure 3.124. Indianfarm Creek access area photo-point images taken from Pin C at the Off-stream Watering site on August 26, 2010; July 7, 2011; and July 17, 2012.**

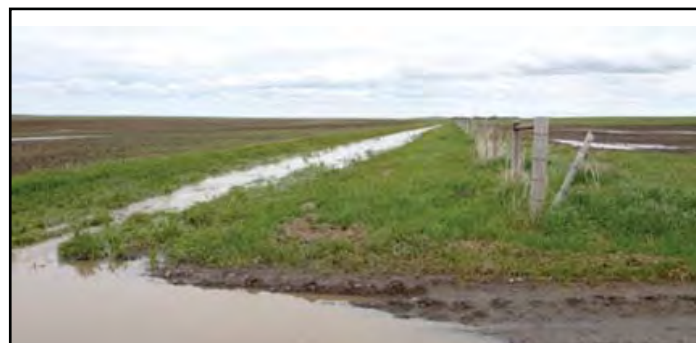
**Figure 3.135.** The tributary that flowed through the Feedlot site, as viewed upstream of Station 26 on June 2, 2010.

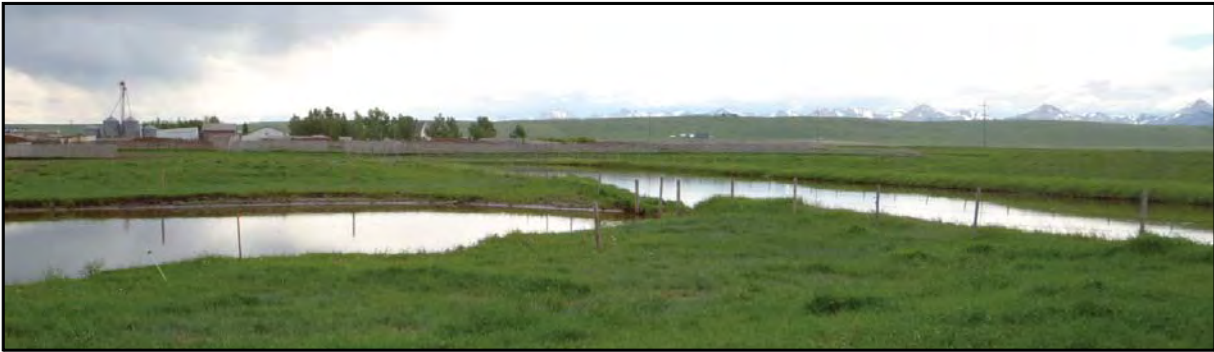
**Figure 3.136. The settling pond (left) and the dugout (right) with the feedlot facility in the background on June 23, 2011.**

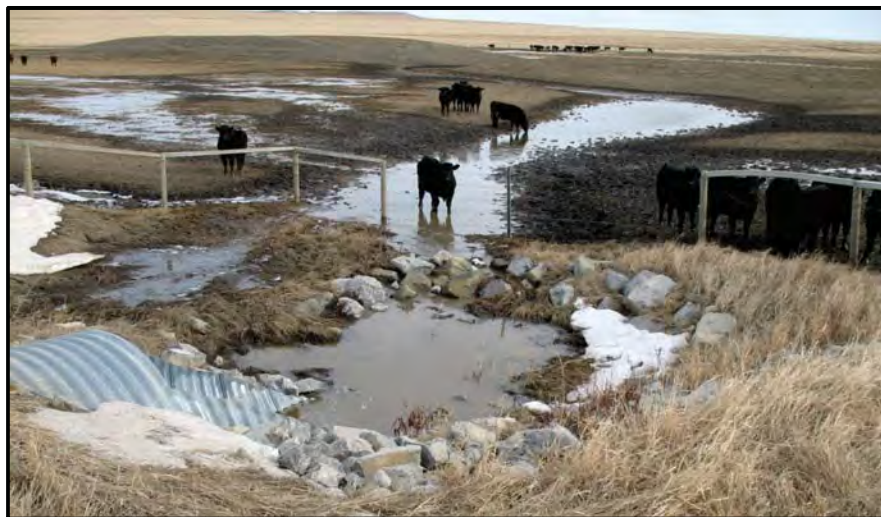
**Figure 3.137. Cattle in the tributary at the Feedlot site as viewed near Station 24 where water from the tributary flowed through culverts under the road. Image was taken on March 3, 2010.**

The seasonal feeding and bedding area generally received cattle in late December and occupied the site until mid-May. As many as 220 cow-calf pairs were fed in this area. When in the feeding and bedding area, cattle had direct access to the tributary. As a result, the area was heavily grazed, physically disturbed, and the tributary extensively impacted by the cattle (Figure 3.137).
