## 3 INDIANFARM CREEK WATERSHED

### 3.1 Introduction

#### 3.1.1 Watershed Description

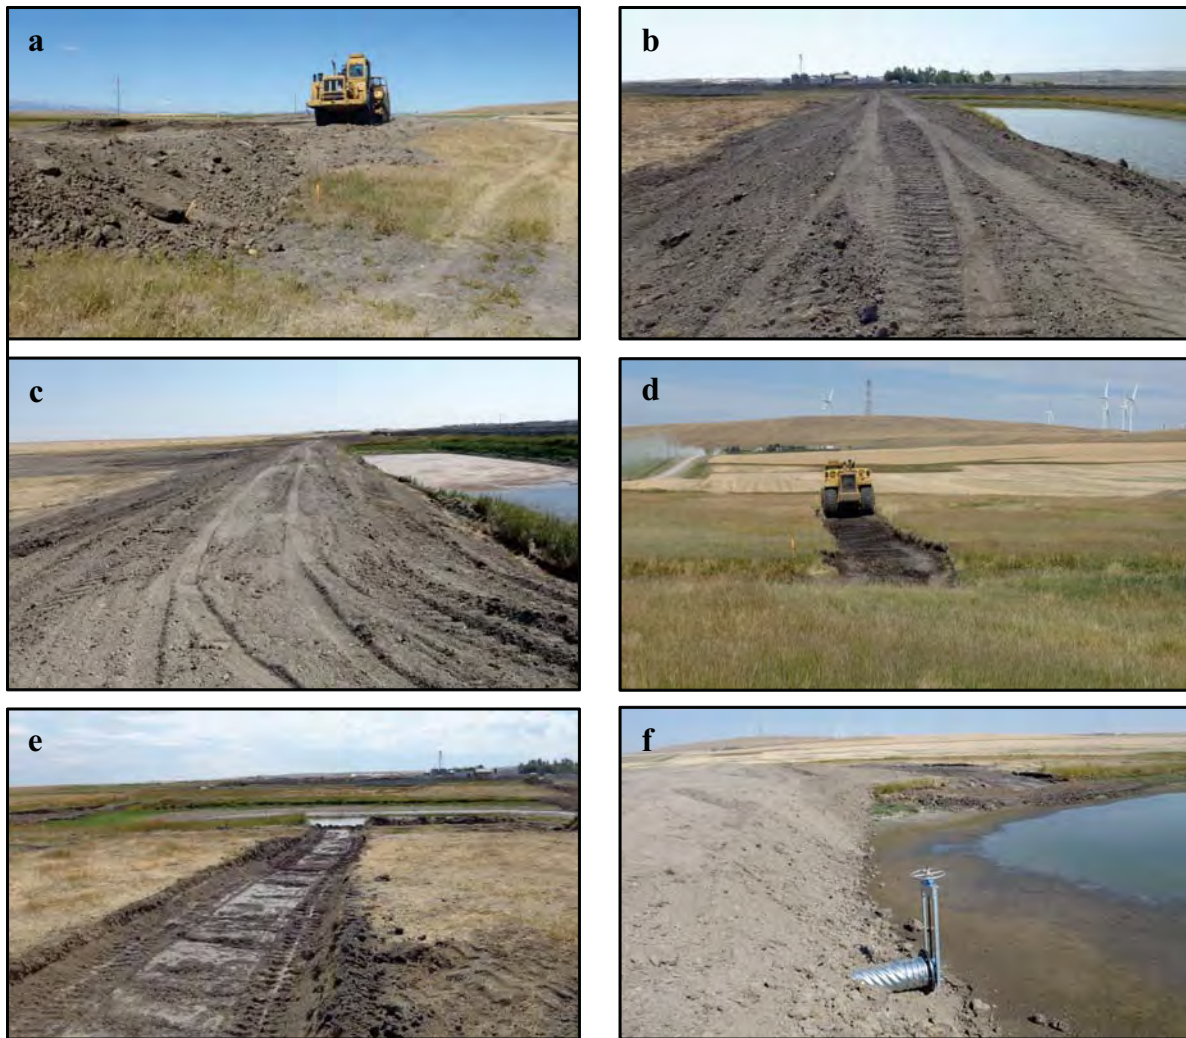
**Figure 3.139. Construction activities at the Feedlot site showing the new berms on the (a) west side and (b) east side of the dugout. Also showing (c) the berm on the north side of the catch basin, (d) the new diversion channel along the west side of the dugout, (e) the diversion channel exiting the north side of the settling pond, and (f) the sluice gate installed between the dugout and settling pond. Images were taken August 24 to September 12, 2011.**

The construction of the berms began on August 24, 2011 using heavy earth-moving equipment and was completed in November 2011. Soil for the berms was obtained from an existing stock pile next to the dugout, the excavated diversion channel, and a newly constructed catch basin northeast of the feedlot. The tops of the completed berms were at the same elevation as the gravel road along the west side of the feedlot. If future flood water reached this elevation, the water will flow over the road and not over the berms. The barbwire fence surrounding the dugout and the wooden fence on the west, north, and east sides of the catch basin were removed prior to construction of the berms.

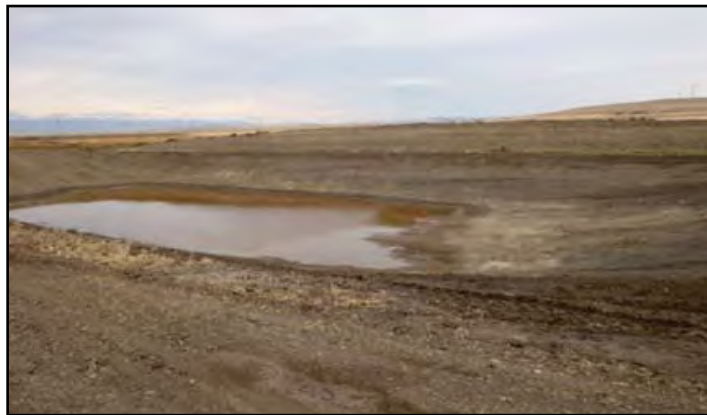
**Figure 3.140. A new catch basin was established northeast of existing feedlot to receive runoff from the new feeding and bedding area. Image was taken October 21, 2011.**

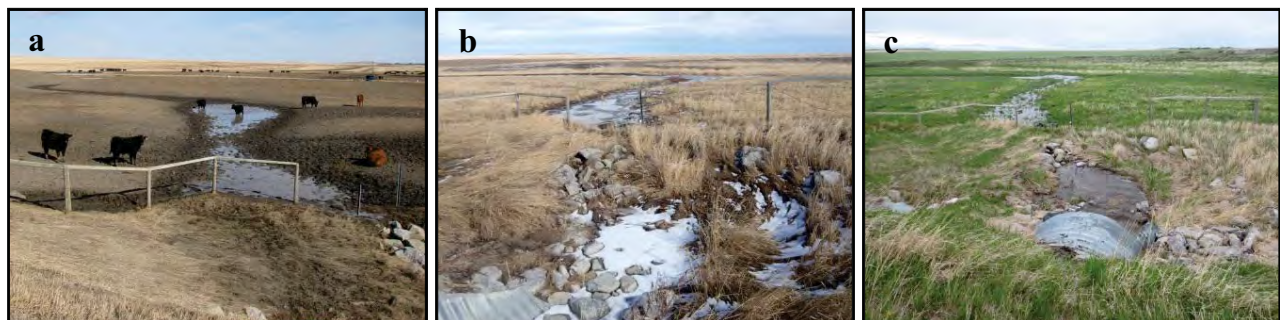
**Figure 3.141. Surface conditions of the feeding and bedding area upstream from Station 24 in (a) the pre-BMP period (image taken on March 12, 2010) and in the post-BMP period on (b) March 12, 2012 and (c) May 13, 2013.**

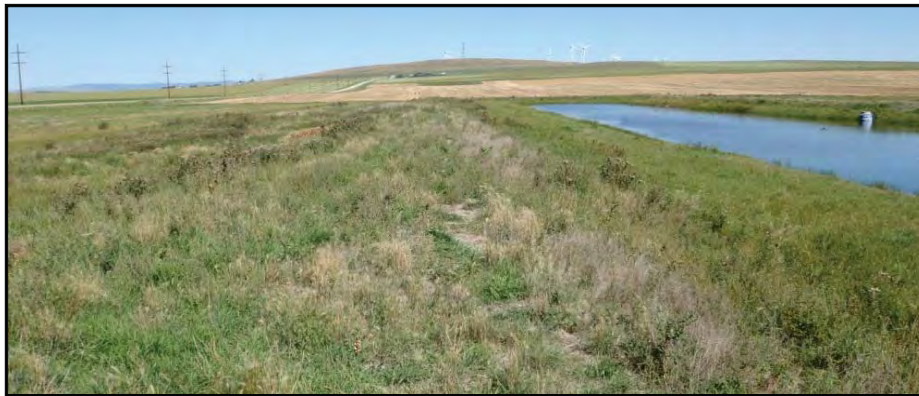
**Figure 3.142. Vegetation growth on the berm along the west side of the dugout at the Feedlot site on August 21, 2013.**

The BMP plan included seeding the newly constructed dugout and catch-basin berms with grass seed. Due to delays caused by weather and other priorities, the berms were not seeded in 2011 or 2012 (Figure 3.142). However, vegetation established naturally on the berms and within 2 yr, they were completely covered. Much of the vegetation was weeds and although weed control may have

helped encourage the establishment of more grass, the established vegetation stabilized the berms and provided protection from erosion.
