Protocol for monitoring Alberta's irrigation infrastructure for invasive mussels

## Protocol for monitoring Alberta's irrigation infrastructure for invasive mussels

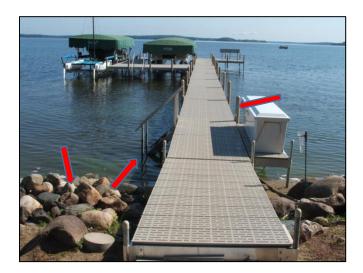
**Figure 6.** Inspection locations at a boat launch, including shoreline rocks, and dock railings and support stakes, as indicated by red arrows.

Location	Structures	
	• Docks, dock floats, and supports	
<b>1. Boat launches / marinas</b> (Figure 6)	<ul> <li>Nearby shoreline rocks</li> </ul>	
1. Doat launches / marmas (Figure 0)	<ul> <li>Cement launching pads</li> </ul>	
	• PVC substrates	
	• Floating docks and swimming platforms	
2. Swimming areas (if present)	• Buoys, ropes, and floating markers	
	Shoreline rocks	
	• Concrete structures (high water mark)	
3. Irrigation outlets	• Areas shallower than 30 m	
	• Intake gates, trash bars

Boat launches and marina areas should be prioritized before swimming areas and irrigation outlets due to the inherent risk posed by watercraft traffic. If PVC substrates have been installed, these should continue to be checked. The PVC substrates provide the observer a good understanding of what may be present below the water surface, especially when visibility conditions are poor, such as when water levels fall far below dock platforms, or if there is poor water clarity, making it difficult to see into the water.

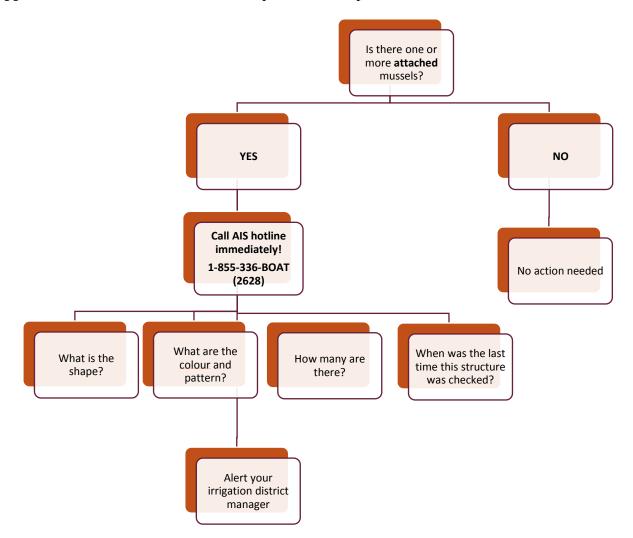
Appendix B. Flow chart for the visual inspection action process.

Make note of any mussels *attached or stuck* to irrigation infrastructure, the size, shape, and number, the location (i.e., boat launch, canal), and how recently the location was last checked. If possible, take a few pictures. You should then call the Aquatic Invasive Species HOTLINE (1-855-336-BOAT [2628]), and relay these details to the dispatcher. In the event that an attached mussel is found on any component of irrigation infrastructure, the appropriate actions, outlined in Appendix B, should be followed.
