Technical Evaluation for the Low Power Automatic Controls (LOPAC) Flow Monitor

Assessed in Current Irrigation Management Practices Study

Joel Cordes, Jennifer Nitschelm, and Roger Hohm
Basin Water Management Section
Irrigation and Farm Water Division
Alberta Agriculture and Rural Development
Lethbridge, Alberta

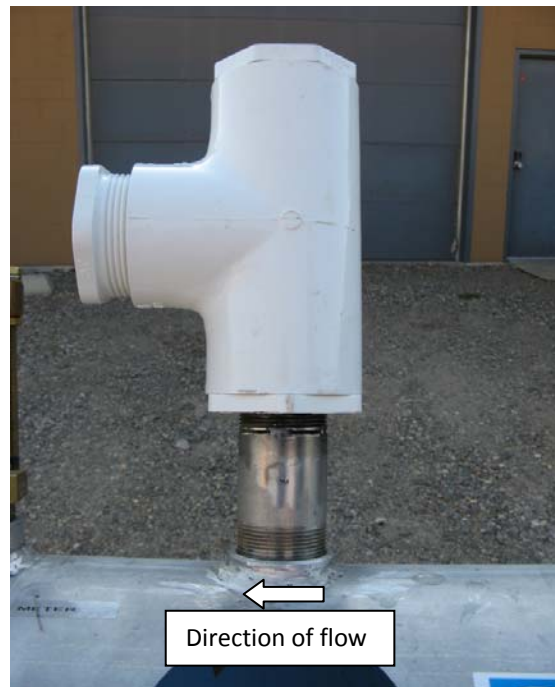
Figure 1. Originally designed LOPAC flow monitor equipped with non resettable counter only (at left) and Model LHE2 with additional PVC housing and data logger (at right).

- The sensor housing is a one and one-half inch diameter stainless steel pipe coupler, approximately three and one-half inches in length. One threaded end provides the connection to the pipe where flow is to be monitored, and the opposite end connects to a standard two and one-half inch PVC threaded tee to provide the housing for the data logger and time counter (Figures 1 and 2).

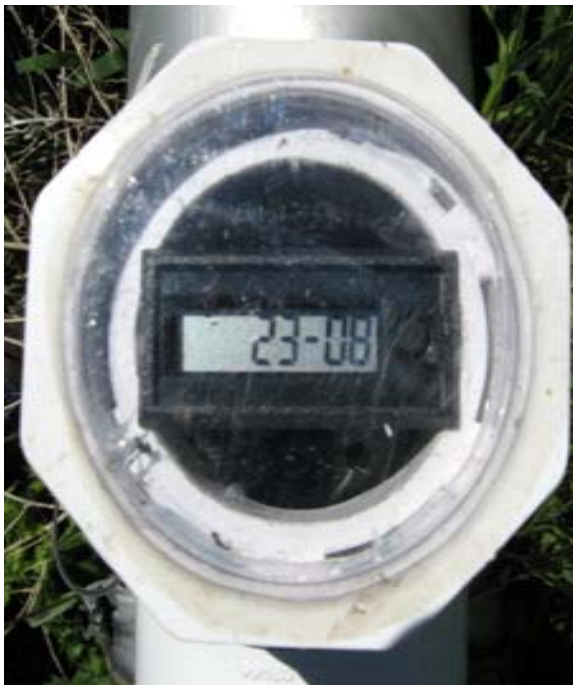
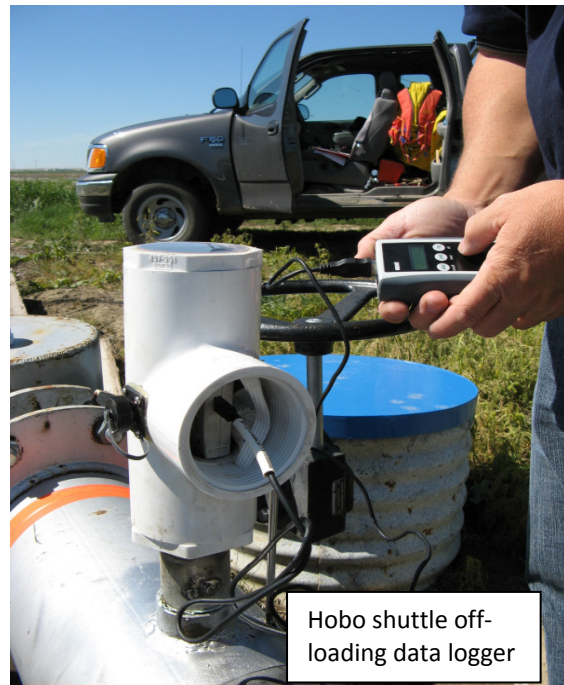
Figure 2. Time counter installed in top of the PVC housing displays time of flow in hours and minutes (at left) and accessing data logger in horizontal portion of PVC housing (at right).

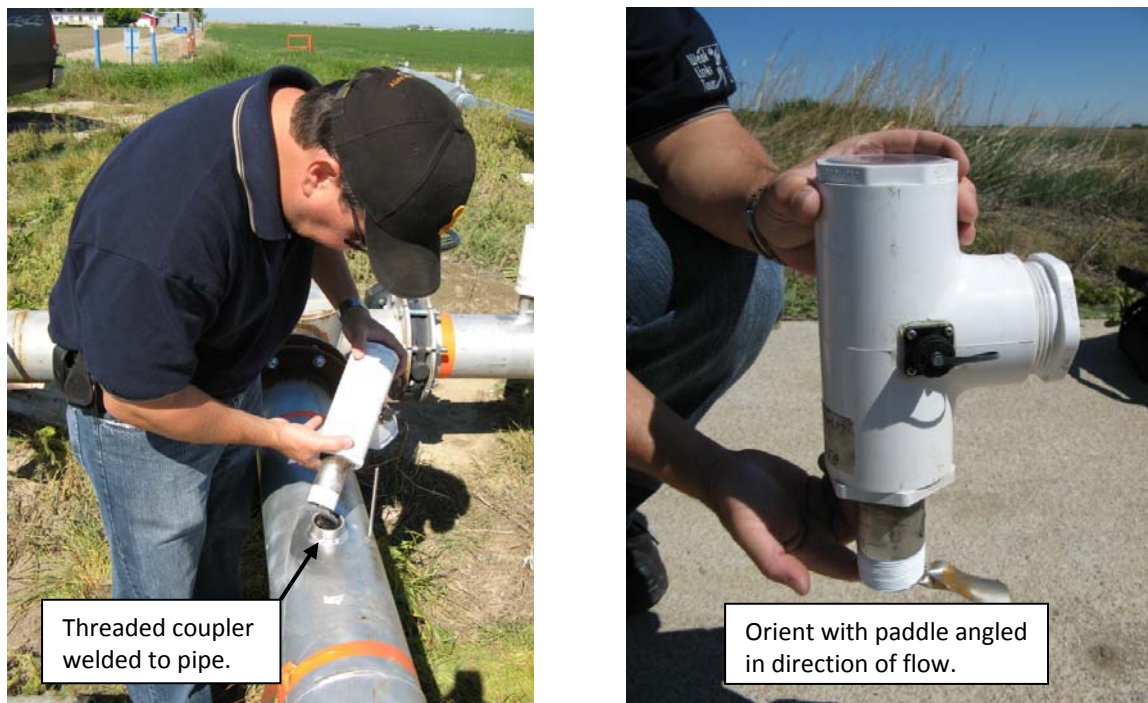
Figure 3. Installing the model LOPAC LHE2 monitor.

To install a LOPAC monitor, a hole is cut into the top of the turnout pipe and a threaded coupler is inserted and welded in place on a level plane. The coupler is used to connect the LOPAC flow monitor to the pipe being monitored. If possible, position the coupler downstream of a shutoff valve so that the monitor can be isolated from the water delivery system in the event that it needs to be removed or replaced. The threaded base of the monitor, being a one and one-half inch diameter by three and one-half inch long threaded nipple, must then be wrapped with thread sealant tape to ensure a proper seal. It is recommended not to use grease or pipe sealant compound, as it may interfere with the movement of the flow vane. The base of the monitor can then be inserted and tightened into the coupler with a pipe wrench. Be careful only to apply torque to the metal fitting and not the upper PVC housing, as it can easily be turned on the opposing end of the fitting (Figure 3). The LOPAC monitor has front and back sides and must be oriented, when tightened, so that the paddle of the flow vane angles in the direction which water flow will occur. Ensure that the two inch plug of the PVC housing is sealed with thread sealant tape as well to protect the Hobo data logger from moisture.

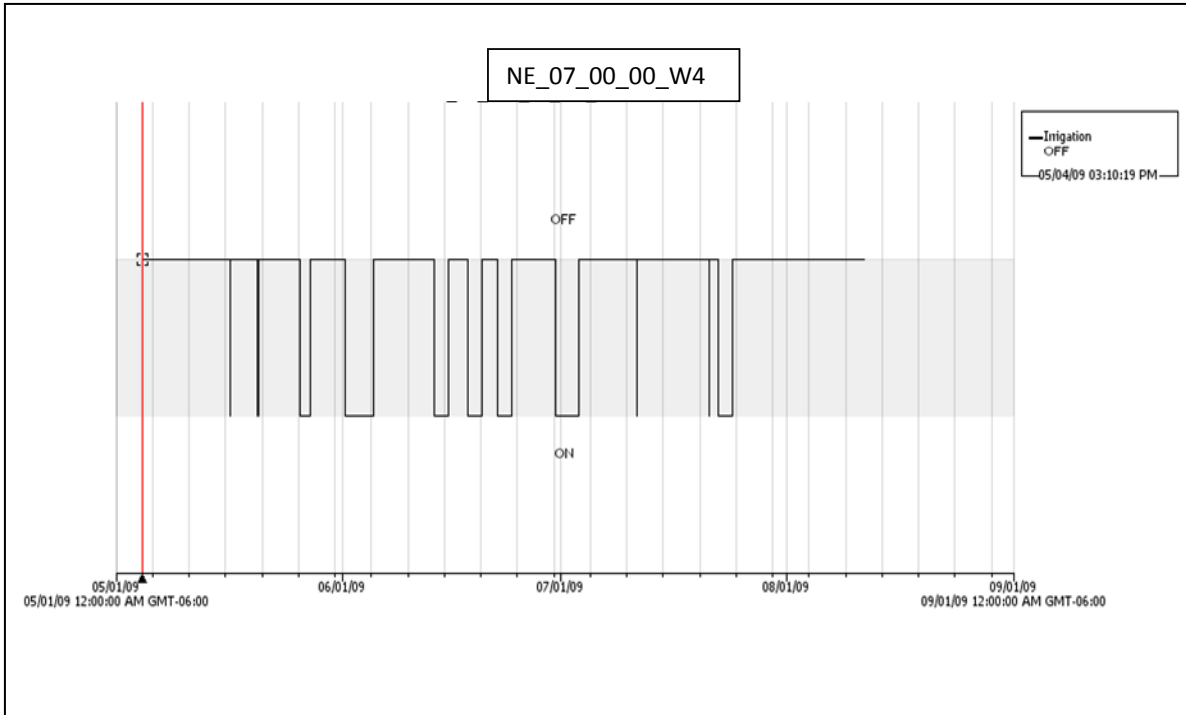
Figure A-1. Hobo logger raw data file displaying irrigation on and off time/dates.
